Shetland Creek Fire (K70910) Detailed Post-Wildfire Natural Hazard Risk Analysis

Prepared by BGC Engineering Inc. for:

British Columbia Ministry of Forests

Post-Wildfire Natural Hazard Partial Risk Assessment (PWNHRA) for 2024 Shetland Creek Fire (K70910) – Spences Bridge, BC

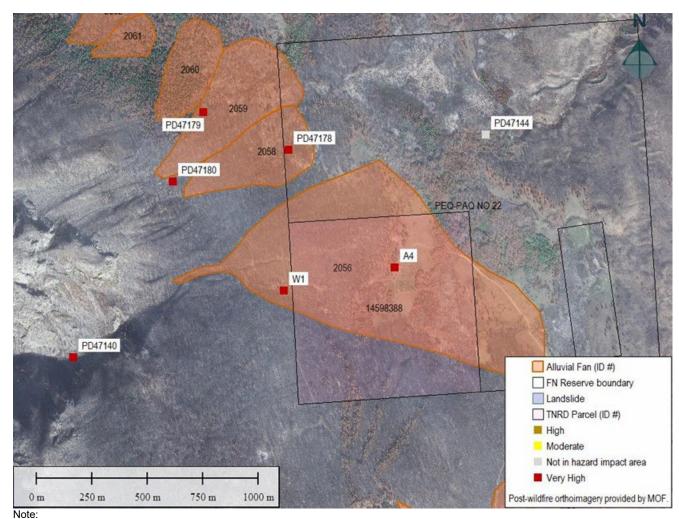
A historical debris flow or debris flood deposit was observed in the main channel at mid fan. The house at location A4 is within 150 m of an active channel. A diversion channel constructed at fan apex is visible in orthoimagery.

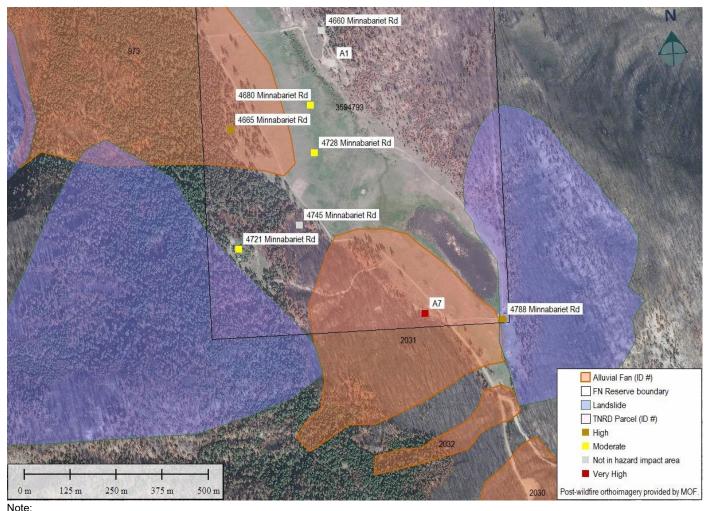
Watershed 12 contains earthflow landslide hazards that may affect geohazard likelihood and magnitude.

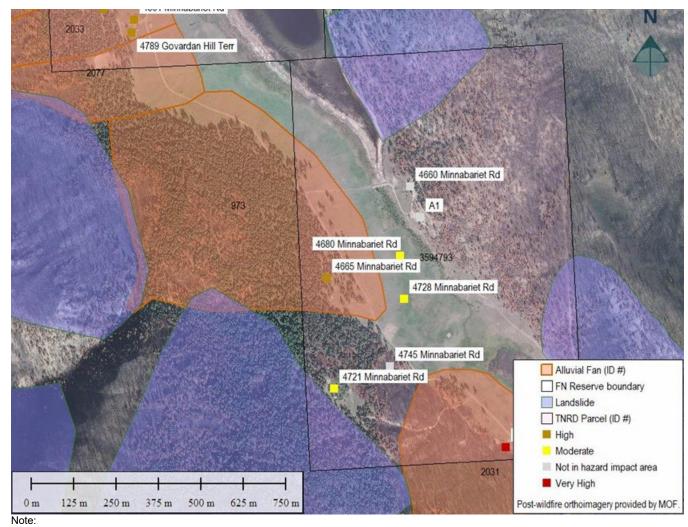
Watershed 9 contains earthflow and rock slope deformation landslide hazards that may affect geohazard likelihood and magnitude. BGC observations recent rilling in the watershed.

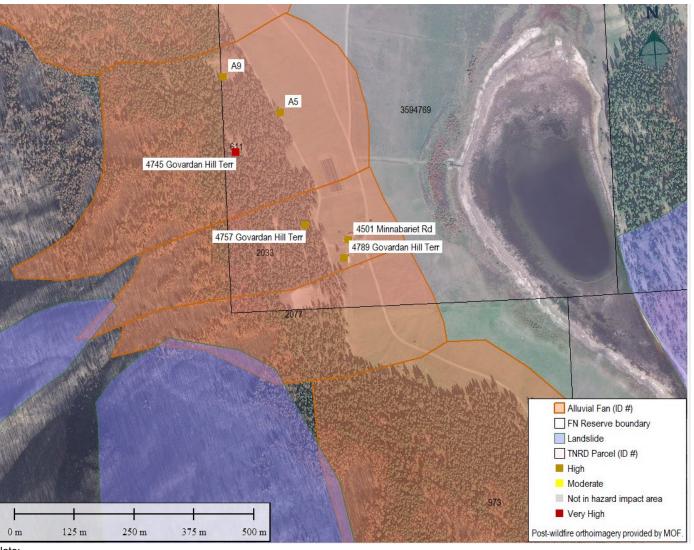
Watershed 11 contains earthflow landslide hazards that may affect geohazard likelihood and magnitude.

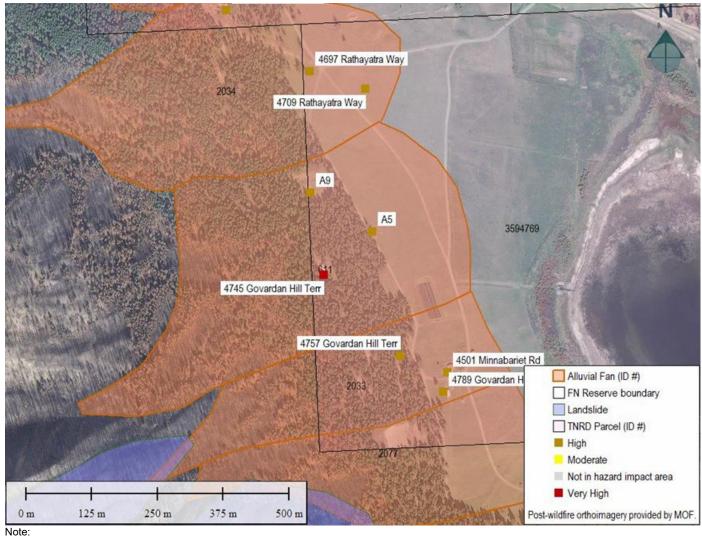
Watershed 12 contains earthflow landslide hazards that may affect geohazard likelihood and magnitude.

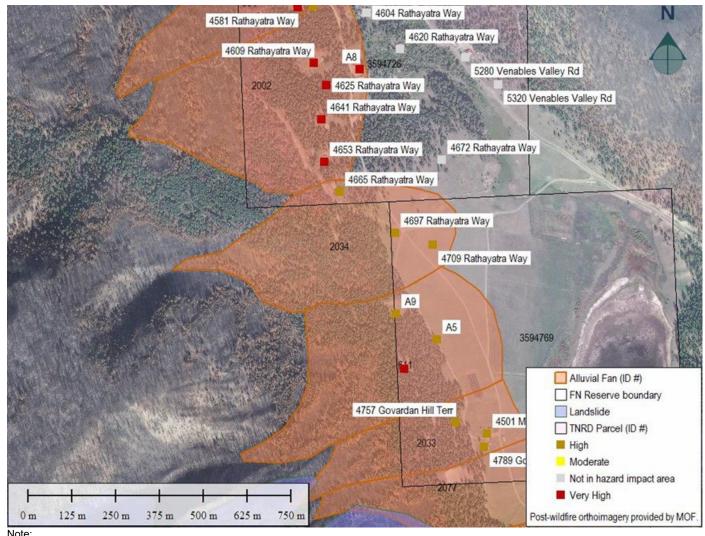
4665 Rathayatra Way may also be exposed to hazards from watershed 14 to the north.

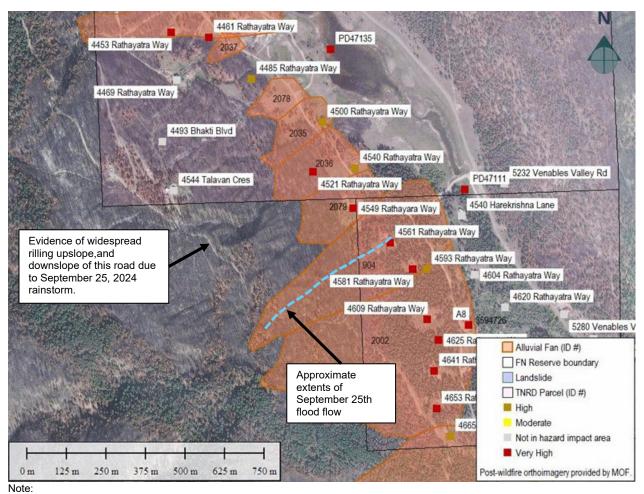
4581 and 4561 Rathayatra Way are between medial and distal fan. Resource road upslope of assets may re-direct flows from watershed 16 towards these assets in unpredictable ways. Overland flooding during September 25, 2024 rainfall directed flow from watersheds 16 and 17 towards 4581 Rathayatra Way. Extensive rilling was observed throughout this area due to the September 25, 2024 rainfall event.

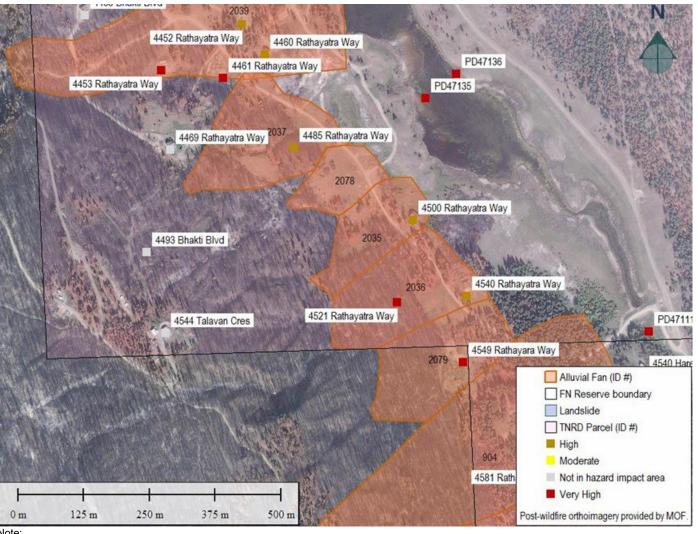
4544 Talavan Cres located above main valley on terrace. There are several small and ill-defined watersheds near the home and no apparent alluvial fans. Homeowner indicated that stream flows are predominantly to the south of the home. Access to 4544 Talavan Cres may be affected by debris flows in adjacent watersheds. The resource road leading to 4544 Talavan Cres may direct debris flows or other watershed processes in unpredictable ways towards adjacent watersheds.

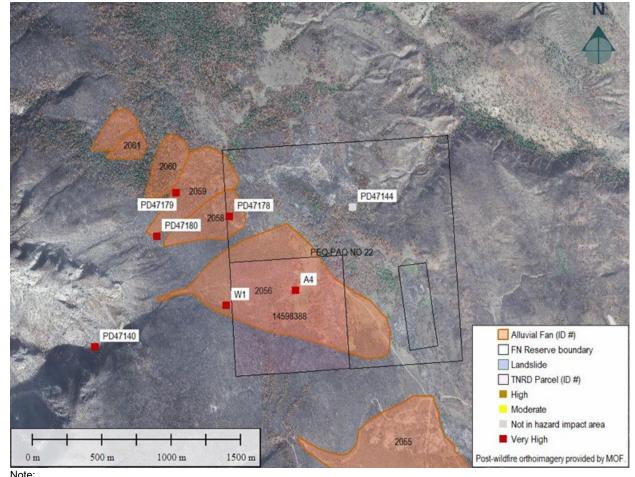
Watersheds 39 and 40 are subject to rockfall hazard and display evidence of debris flow activity along channel.

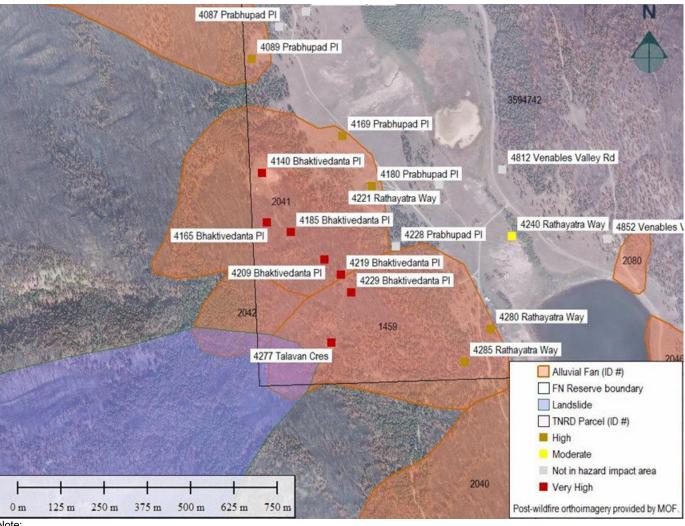
Watersheds 28 and 29 contains earthflow landslide hazards that may affect geohazard likelihood and magnitude. Evidence of historical debris flow or debris flood deposits were observed within 10 m of the home at 4277 Talavan Cres.

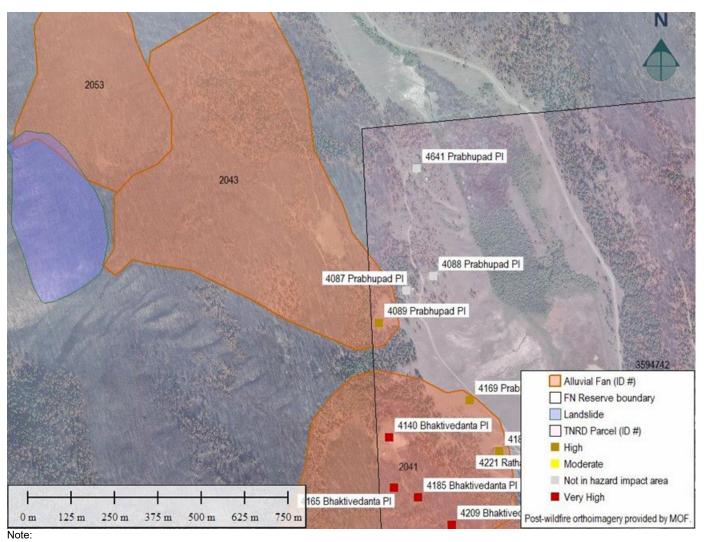
Addresses 4087, 4088, and 4641 Prabhupad Pl are located on a glacial deposit and are elevated above the alluvial fan.

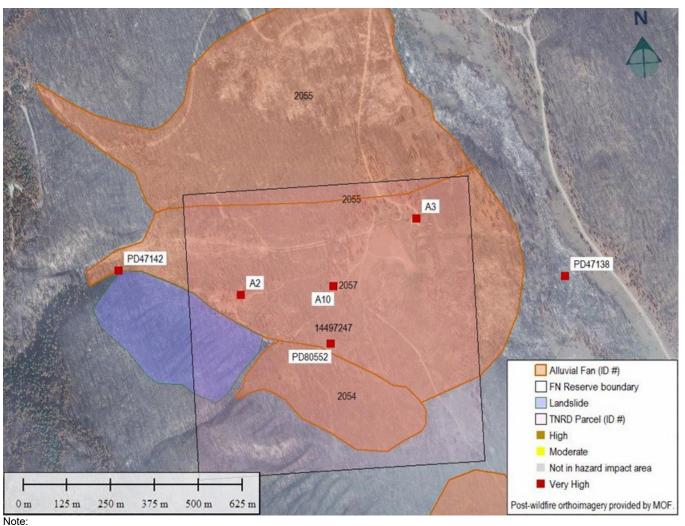
Several cabins (no known address) burned down on the property with an estimated location of A10. Additional cabin locations were not included in the partial risk assessment. Watershed 56 contains resource roads in the upper watershed, which may affect the hazard likelihood and/or magnitude. These roads were not observed during BGC's field program. Property may be affected by additional hazards from watershed 57, which contains a resource road that may alter drainage patterns on the alluvial fan.

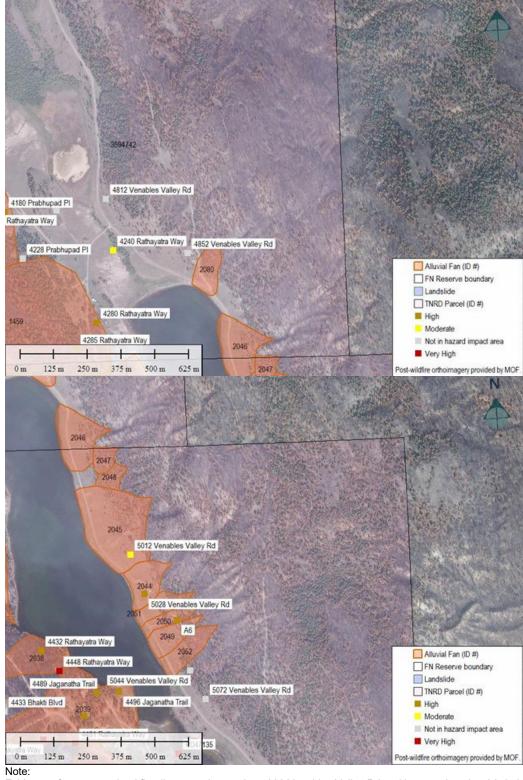
Evidence of recent overland flooding was observed at 5028 Venables Valley Rd and home at location A6 during helicopter overflights. There is evidence of a possible engineered channel on Fan 2045 that was constructed at an unknown date.

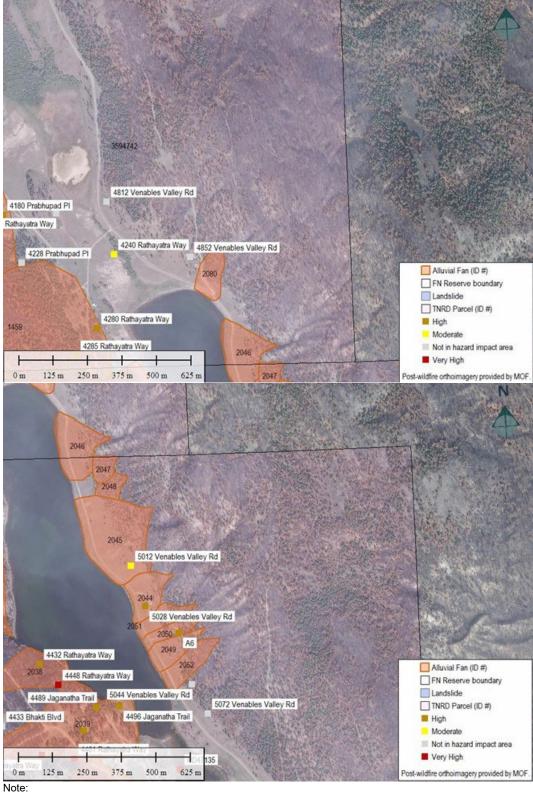
Evidence of recent overland flooding was observed at 5028 Venables Valley Rd and home at location A6 during helicopter overflights. There is evidence of a possible engineered channel on Fan 2045 that was constructed at an unknown date.

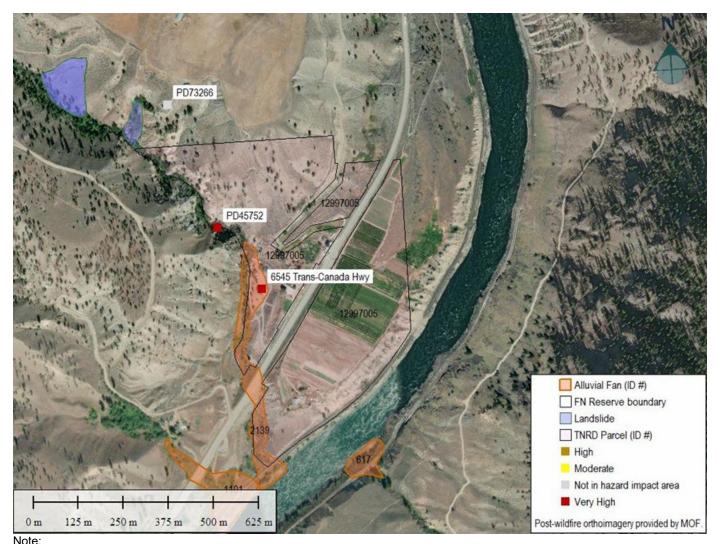
Hilltop Campground is on the low terrace proximal to main channel. The campground has historically flooded during freshet.

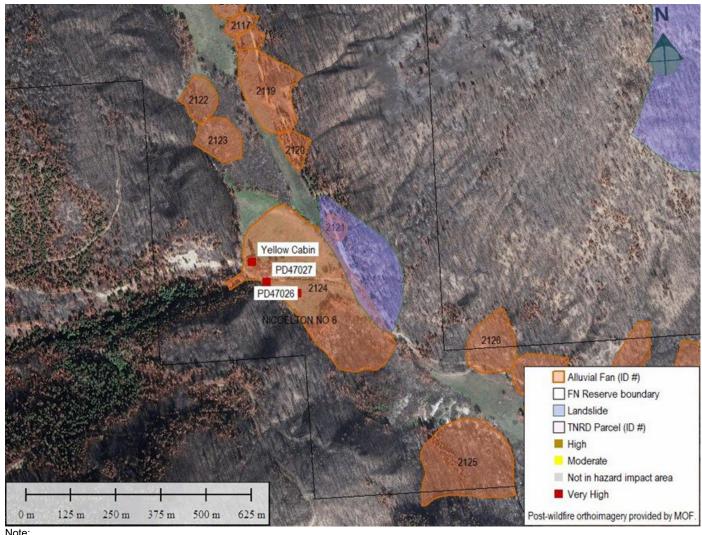
Spence Creek was diverted into a ditch some time in the last decade and currently runs alongside the resource road. The channel used to historically flow towards PD47026.

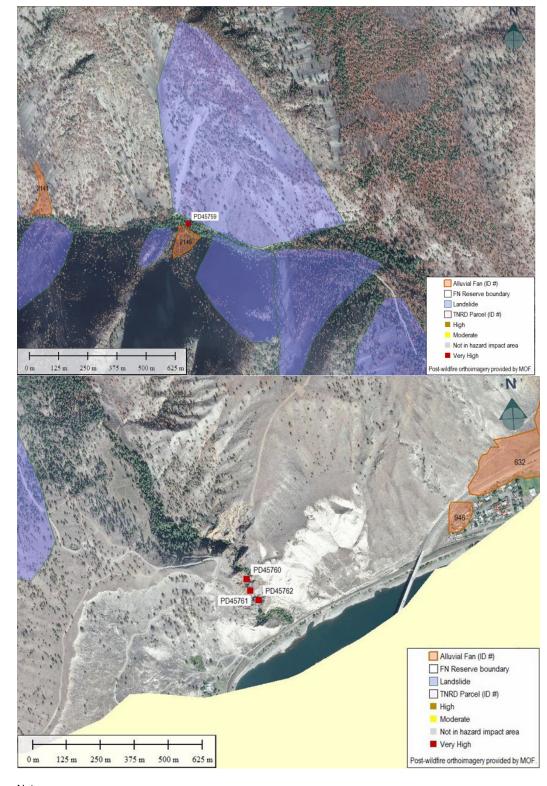
Note: Murray Creek had muddy flows during the last intense rainfall event (July 2023). PD45758 and PD47114 are shown on Drawing 03.

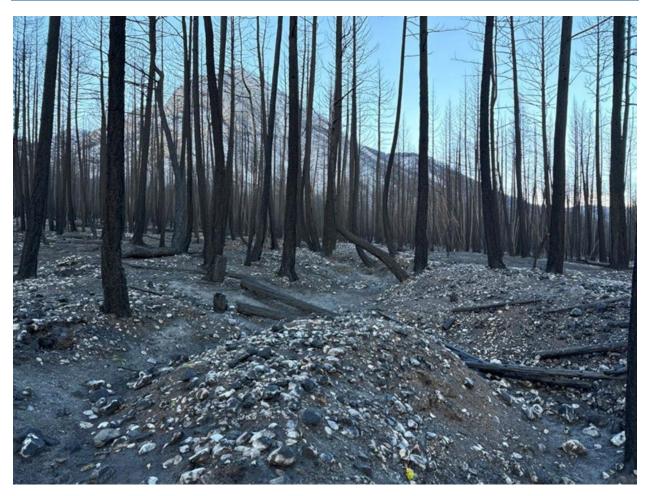
Photo D-2 Historical debris flow or debris flood deposits at mid fan at Blue Earth Farm. Photo taken by BGC on November 17, 2024.

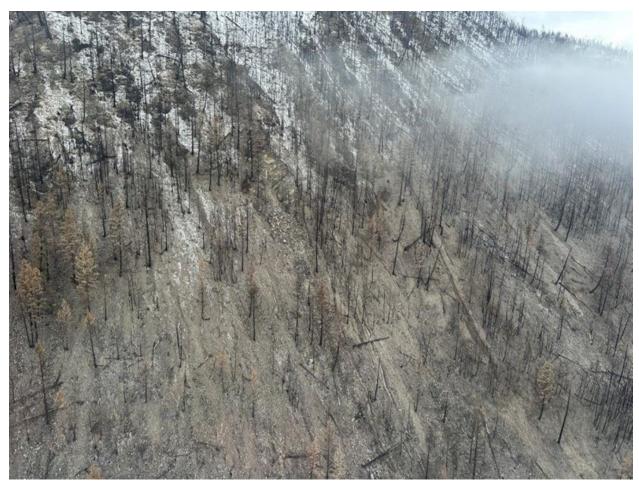
Photo D-7 Photo of the hillslope near Watershed 9 and above 4665 Minnabariet Rd. Rill and gully erosion are visible on the hillslope. Photo taken by BGC on November 18, 2024.

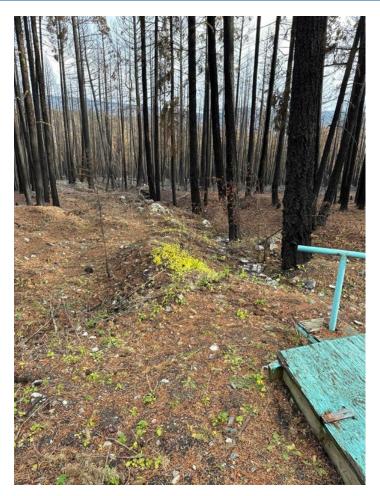
Photo D-14 Historical debris flow deposits at fan apex on hazard 904 above 4500 block of Rathayatra Way. Photo taken by BGC on November 17, 2024.

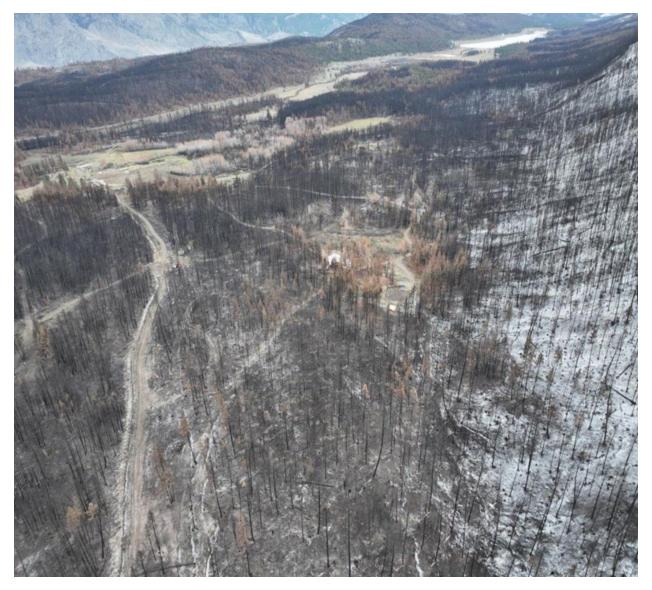
Photo D-26 Aerial overview photo looking south at Bhumi Farm showing the debris slide hazard (far right-side slope) and the alluvial fan (center). Photo taken by BGC on November 18, 2024.

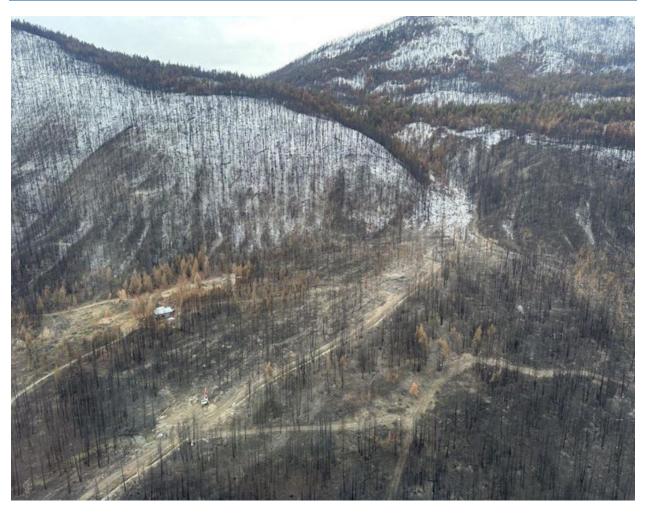
Photo D-27 Aerial overview photo looking west at Bhumi Farm note the cabin A2 on the left in proximity to both debris slide and debris flow hazards. Photo taken by BGC on November 18, 2024.

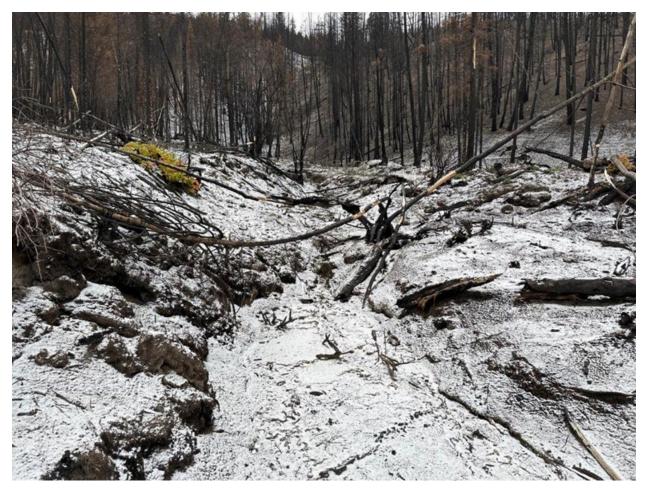
Photo D-28 Historical debris flow or debris flood channel near fan apex at Bhumi Farm. Photo taken by BGC on November 16, 2024.

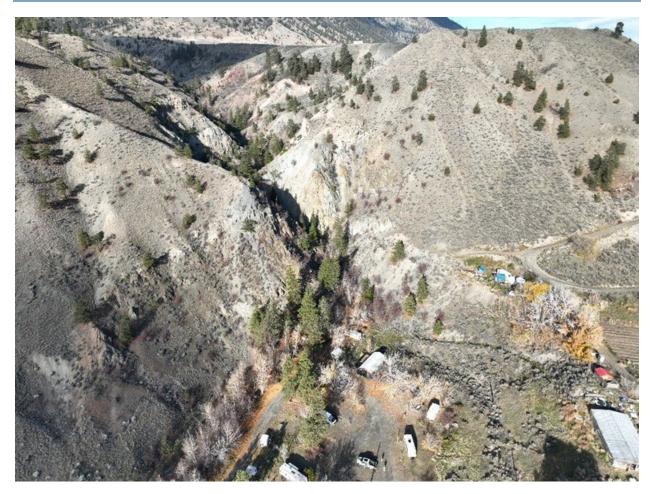
Photo D-30 Aerial overview photo looking north at the Hilltop Farms campground near the fan apex. Note the campground has historically flooding during the freshet. Photo taken by BGC on November 19, 2024.

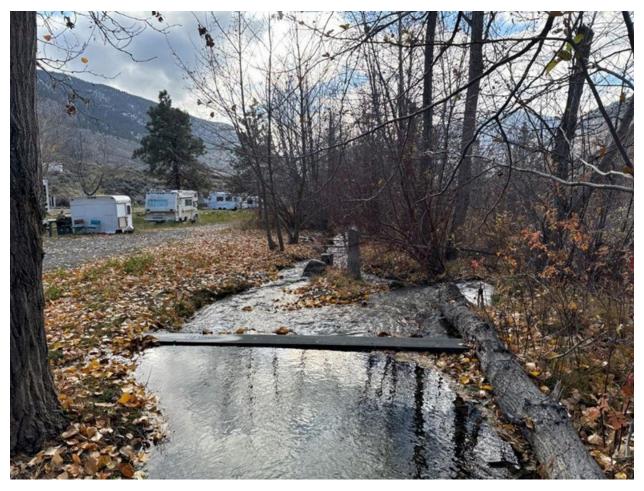
Photo D-31 Looking downstream (south) along Twaal Creek at the Hilltop Farms Campground. Note the low channel confinement. Photo taken by BGC on November 19, 2024.

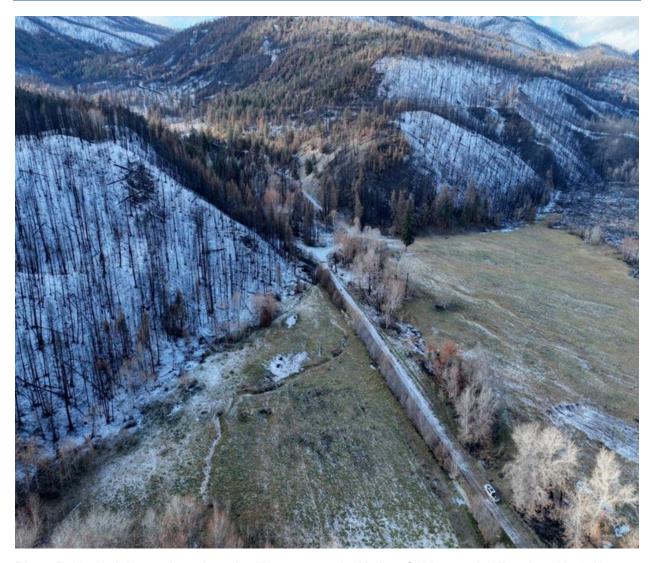
Photo D-33 Aerial overview photo looking west at the Yellow Cabin area in Nicoelton No 6. Note the channel has been re-routed to be parallel and south of the road within the last 10 years. Photo taken by BGC on November 18, 2024.

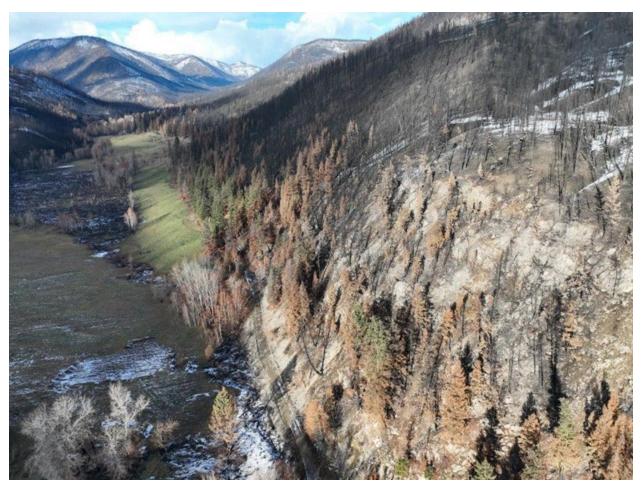
Photo D-34 Aerial overview photo looking north at a rockfall source area above Twaal Creek Rd and east of the Yellow Cabin. Photo taken by BGC on November 18, 2024.

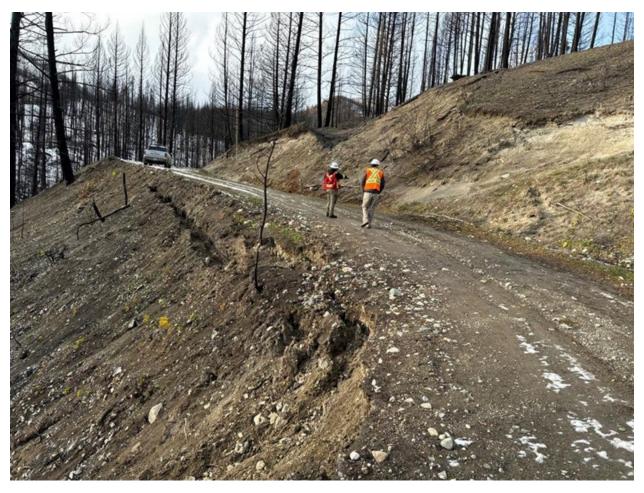
Photo D-35 Looking north along Twaal Creek Rd and landslide at the road. Photo taken by BGC on November 18, 2024.

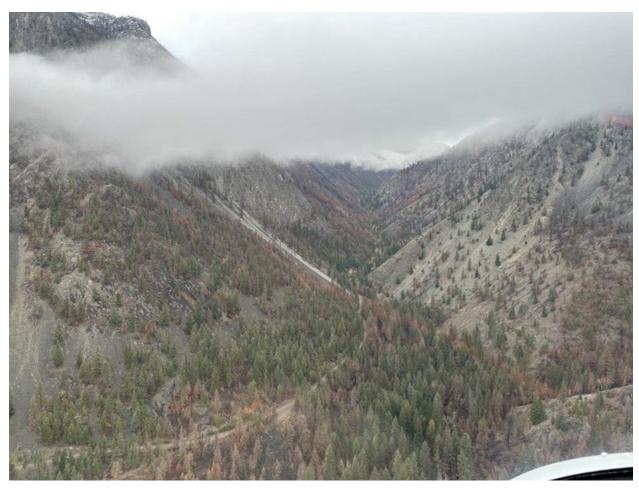
Photo D-37 Aerial photo looking west at the Murray Creek FSR. Note the colluvial slopes on both sides of the road and the road entering an area higher valley confinement.

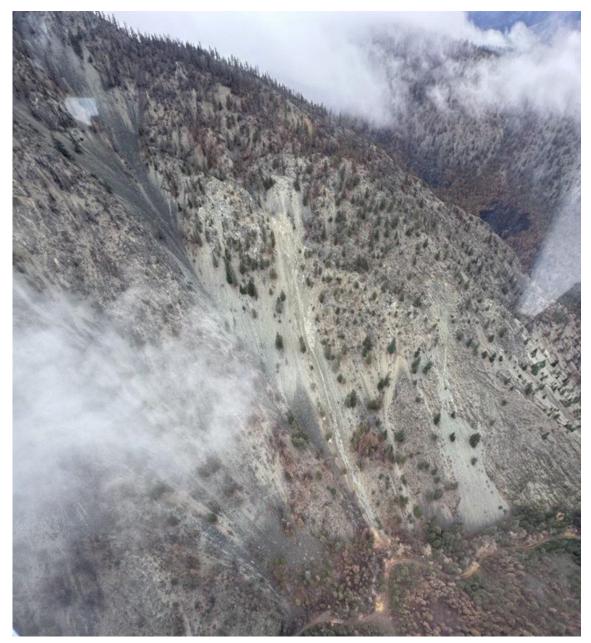
Photo D-38 Aerial-oblique photo of Murray Creek Rd and one of the three bridge crossings. Note the high relief and high sediment supply above the road.
