# Pritchard Wastewater Master Plan

Thompson Nicola Regional District

April 2018

Project No. 379-491

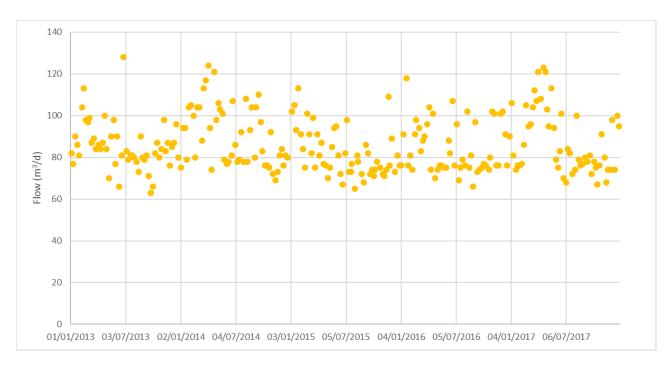
FIGURE 1-2: FLOW TREND - PRITCHARD COMMUNITY SEWER SYSTEM

Daily flows appear to be stable throughout the year and there has been no apparent trend from one year to the next in the period from 2012 to 2017. The TNRD report issues with infiltration in the spring, which have been gradually addressed by raising manhole covers. In addition, residents of trailers must run taps to prevents pipes freezing, which increases winter flows.

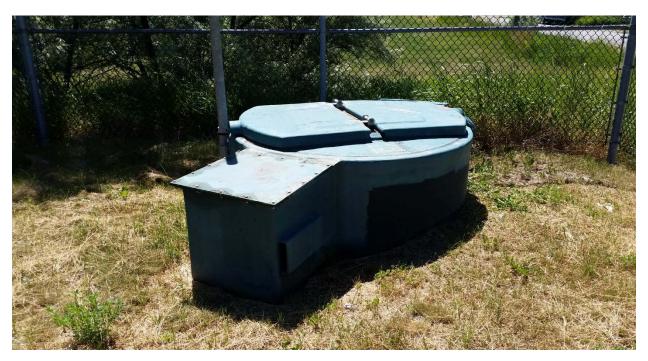
FIGURE 2-2: PRITCHARD LIFT STATION - RIVER ROAD

FRP lift stations are non-corrodible and long lasting, apart from the metal fittings which tend to require occasional replacement depending on the nature of the atmosphere in the chamber. This chamber was in good condition. Some corrosion of the aluminum ladder was noted. An FRP ladder would be preferable.

The paint on the standby generator is deteriorating but it is understood that the unit is in otherwise acceptable condition.

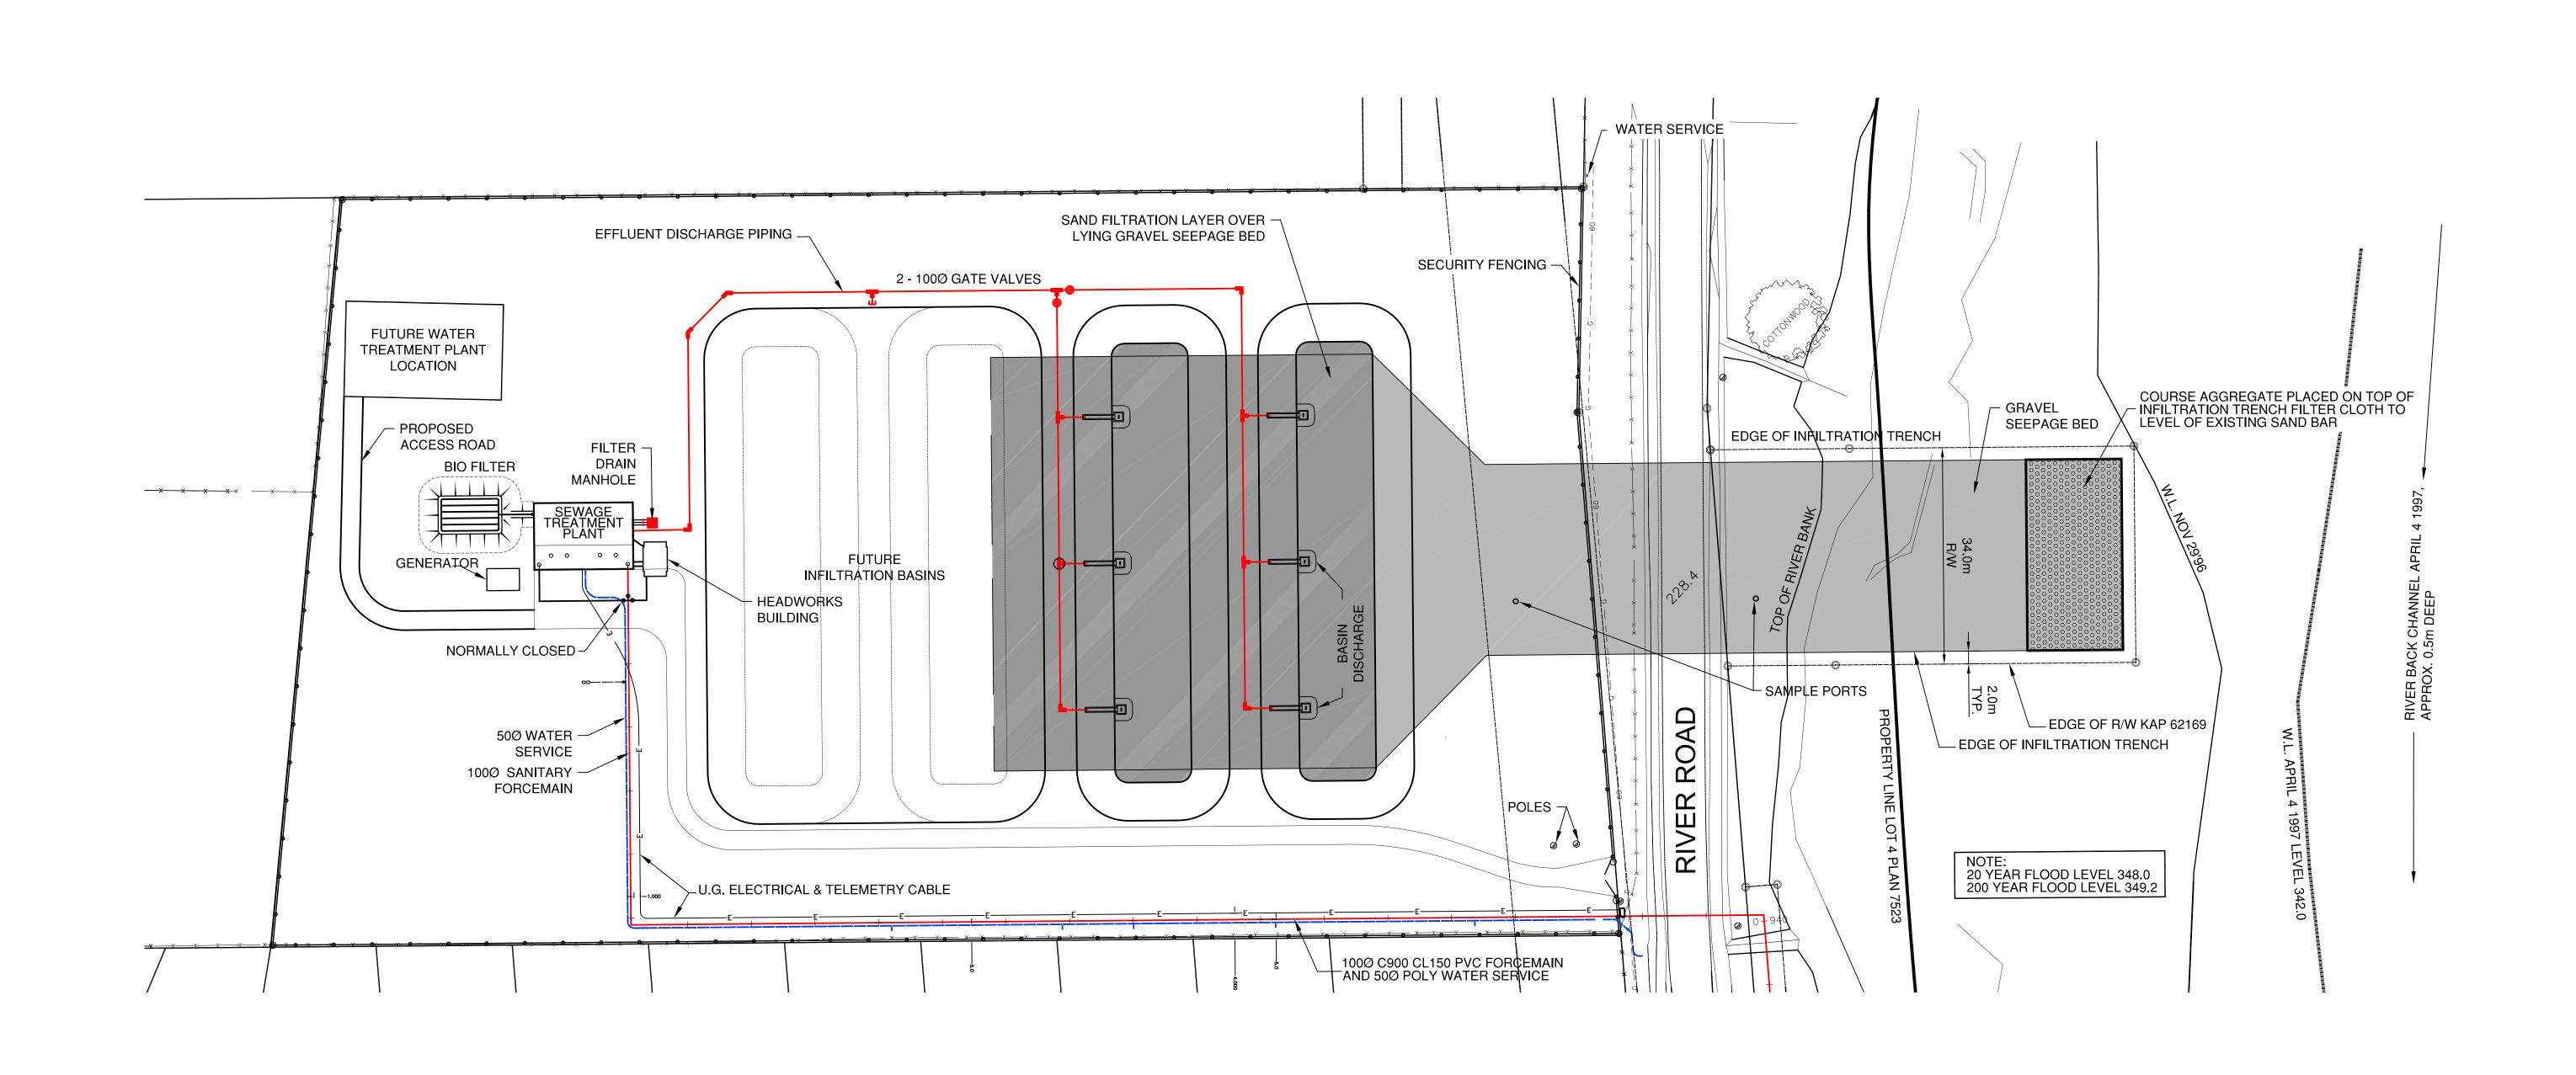
TNRD MASTER PLAN
PRITCHARD SEWAGE
TREATMENT PLANT
SITE PLAN

The infiltration bed is shown in plan view on Figure 3-2 and in section on Figure 5-1.

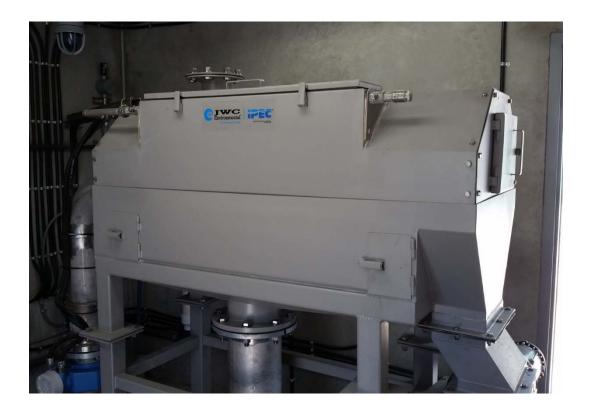
FIGURE 3-3: INTERNALLY-FED ROTARY DRUM SCREEN

The station is designed to screen the wastewater as it is pumped to the plant by the lift station. Screenings are compressed to remove excess water and minimise the quantity for disposal. Screenings are disposed of to a small garbage bin. The screened wastewater flows by gravity to the primary settling tanks. The purpose of the screening facility is to remove inorganic solids prior to the primary storage tanks, which was prone to accumulating mats of non-biodegradable solids. It also protects the pumps and trickling filter nozzles from these solids.

The system is operating without any serious issues and is in new condition.

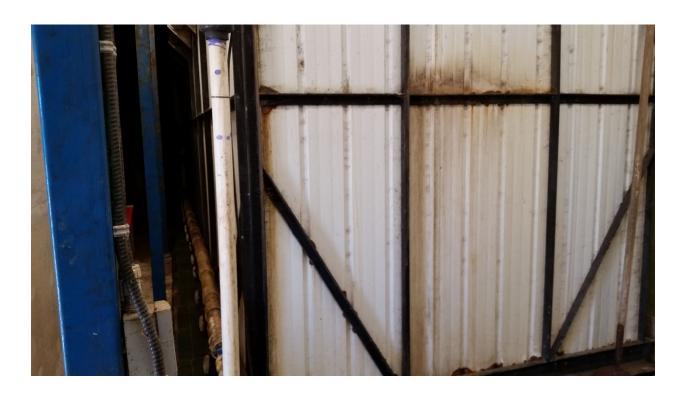
FIGURE 3-4: TRICKLING FILTER CLADDING

The trickling filters and recirculation tank were not inspected internally, but are understood to be in acceptable condition. However, the trickling filter exterior cladding has deteriorated to the point where it now requires replacement. The function of the cladding is to prevent splashing of the effluent outside the structure. It is not a structural element required to support the media.

There are non-corrodible alternatives for the replacement cladding such as FRP and plastic sheets. It would be feasible to wet apply FRP to the exterior of the filter cladding while leaving the existing cladding in place, or, preferably to remove the cladding and replace it with new cladding. It is not practical to replace the cladding on the rear wall without dismantling the filters, as there is no practical access.

Costs for the replacement of the trickling filter cladding are primarily for labour. The costs are highly dependant on methodology and the effect of risk pricing. As a result, there is considerable uncertainty regarding costs and a collaborative approach to procurement should be considered. The work should be undertaken in stages so as to avoid a deterioration of effluent quality, which would require regulatory authorisation.

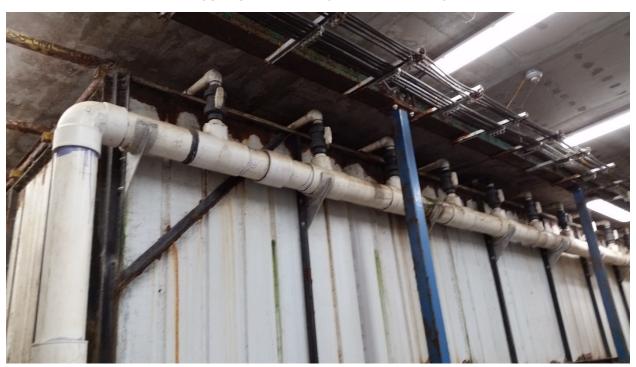
FIGURE 3-5: TRICKLING FILTER SPRAY SYSTEM

The trickling filter consists of a bed of plastic media which supports biomass growth. Wastewater is applied at a controlled rate using an evenly spaced array of fixed nozzles. As the wastewater trickles down through the media, organic matter is bio-degraded by microorganisms living on the media. The treated wastewater is then collected by a recirculation tank.

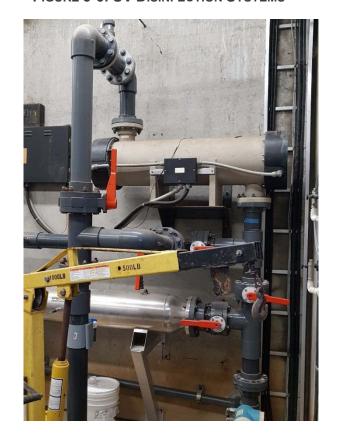
FIGURE 3-6: UV DISINFECTION SYSTEMS

The sand filters discharge effluent to the Effluent Holding Tank, where the effluent pump directs effluent through flow meter and a pressurised ultraviolet (UV) disinfection unit. The operating UV disinfection unit is the original Waterguard reactor (model WG-12-L-G) dating from 1998. The TNRD installed a replacement UV unit (Spectral Innovations) more recently<sup>2</sup>, but electrical and mechanical failures have prevented the use of this unit.

The Waterguard unit is achieving disinfection targets and is in acceptable condition. Unfortunately, it has reached an age where it is increasingly difficult to source replacement lamps.

Because the newer Spectral Innovations unit is not reliable, a new UV unit should be purchased to replace both systems.

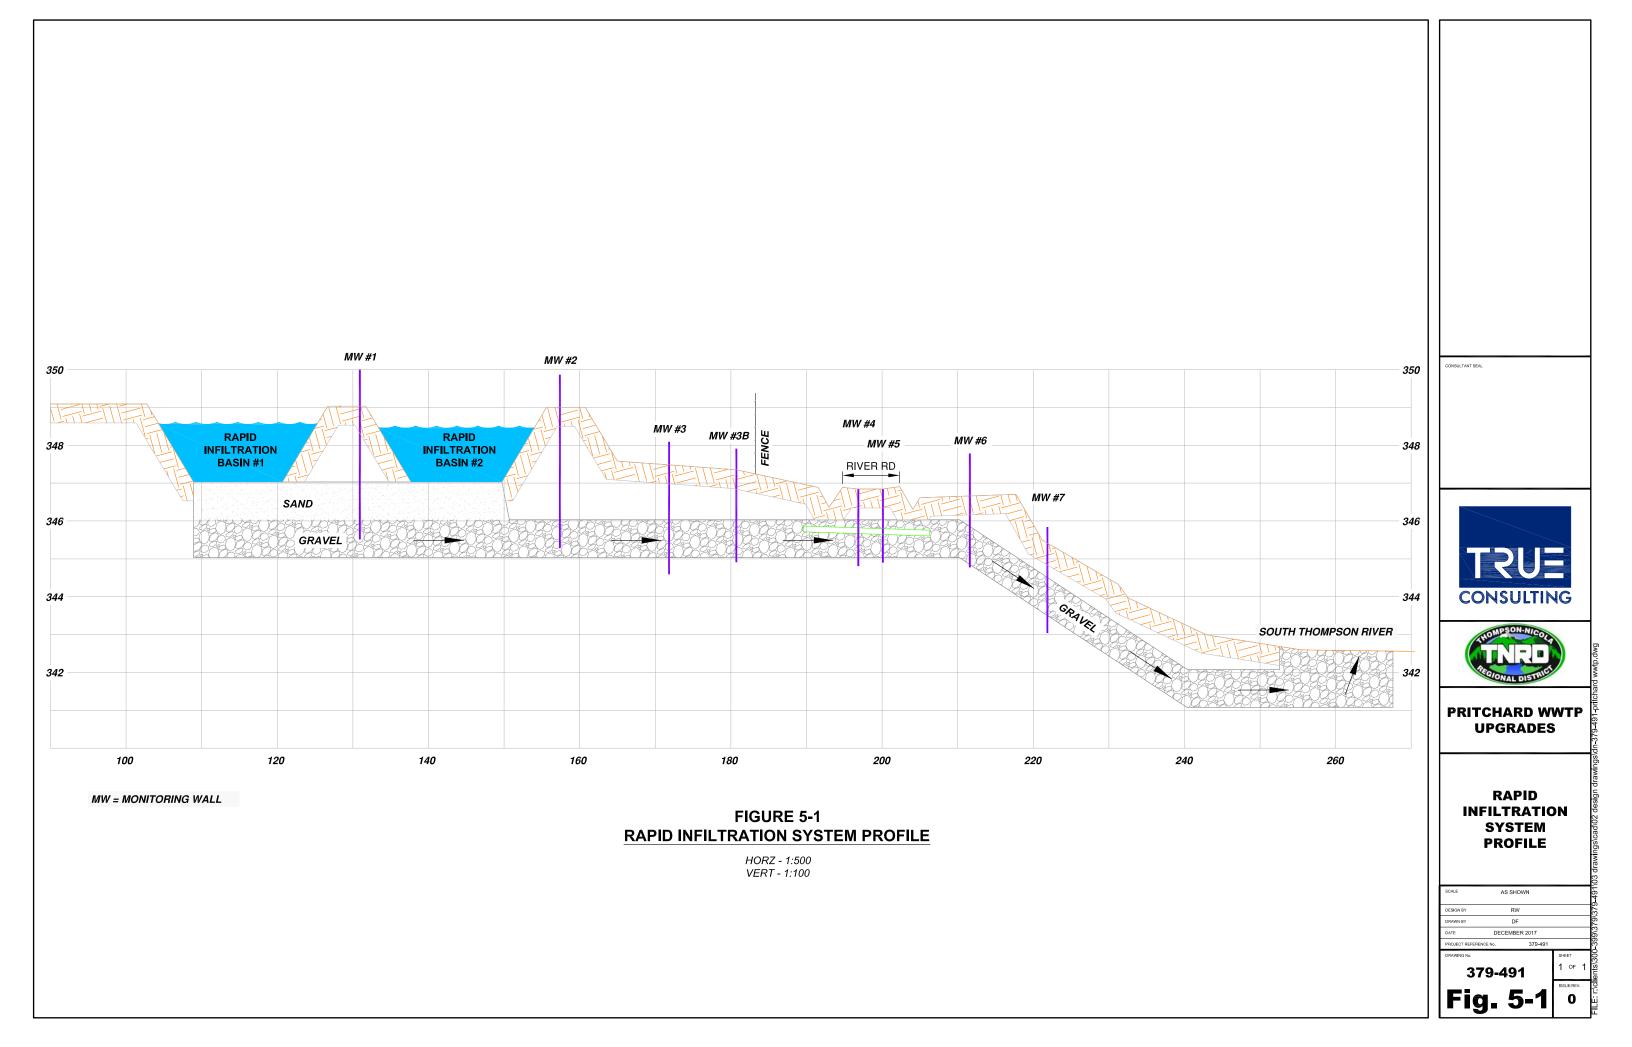
The river exfiltration area was scarified in the fall of 2012 and a hydraulic survey was undertaken using piezometers between May 2<sup>nd</sup> and July 26<sup>th</sup> 2013. The study period started with the river level high enough to cover the exfiltration area and finished with the river level near the annual peak. Over this period the water column of the hydraulic profile remained high through the gravel layer until Monitoring Well #3, then dropped to near the bottom of the gravel layer by River Road. By September of 2013 both Rapid Infiltration Basins had drained completely as a result of the scarification in the previous fall. The observations from May to July 2013 indicated that the most significant head losses were the area between MW-3 and MW-4. TRUE investigated the area between MW-3 and MW-4 further by installing another test hole prior to the July 3rd reading. This indicated that the slope of the grade line is constant between MW-3 and MW-4. TRUE did not measure the water column in freezing conditions, as the mean daily temperature was in the low teens by May 2013. This means that the impact of frost penetration in the exfiltration area was not measured in this study.

The TNRD propose to dig test pits in the gravel layer to check for blockage by migrating silts and undertake further piezometer monitoring. The TNRD also propose to install a clay cap over the seepage bed on the upgradient side of River Road to safeguard against future surfacing of the effluent, which affects the use of the road.

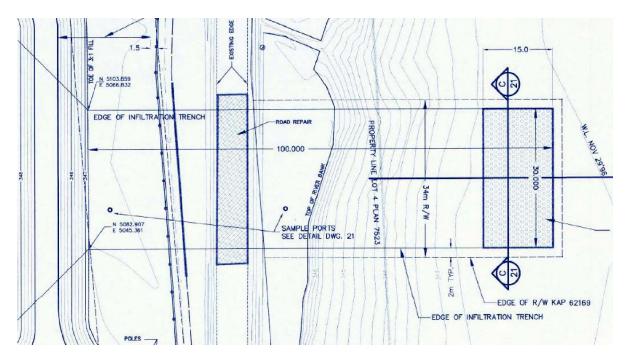
FIGURE 6-1: EFFLUENT DISPOSAL AREA RIGHT OF WAY

The discharge area is located inside a 34m wide by 100m long right of way as it crosses the MOTI road dedication and enters the river channel.
