Pinantan Lake

FIRESMART COMMUNITY ASSESSMENT REPORT

Thompson Nicola Regional District

October 2019

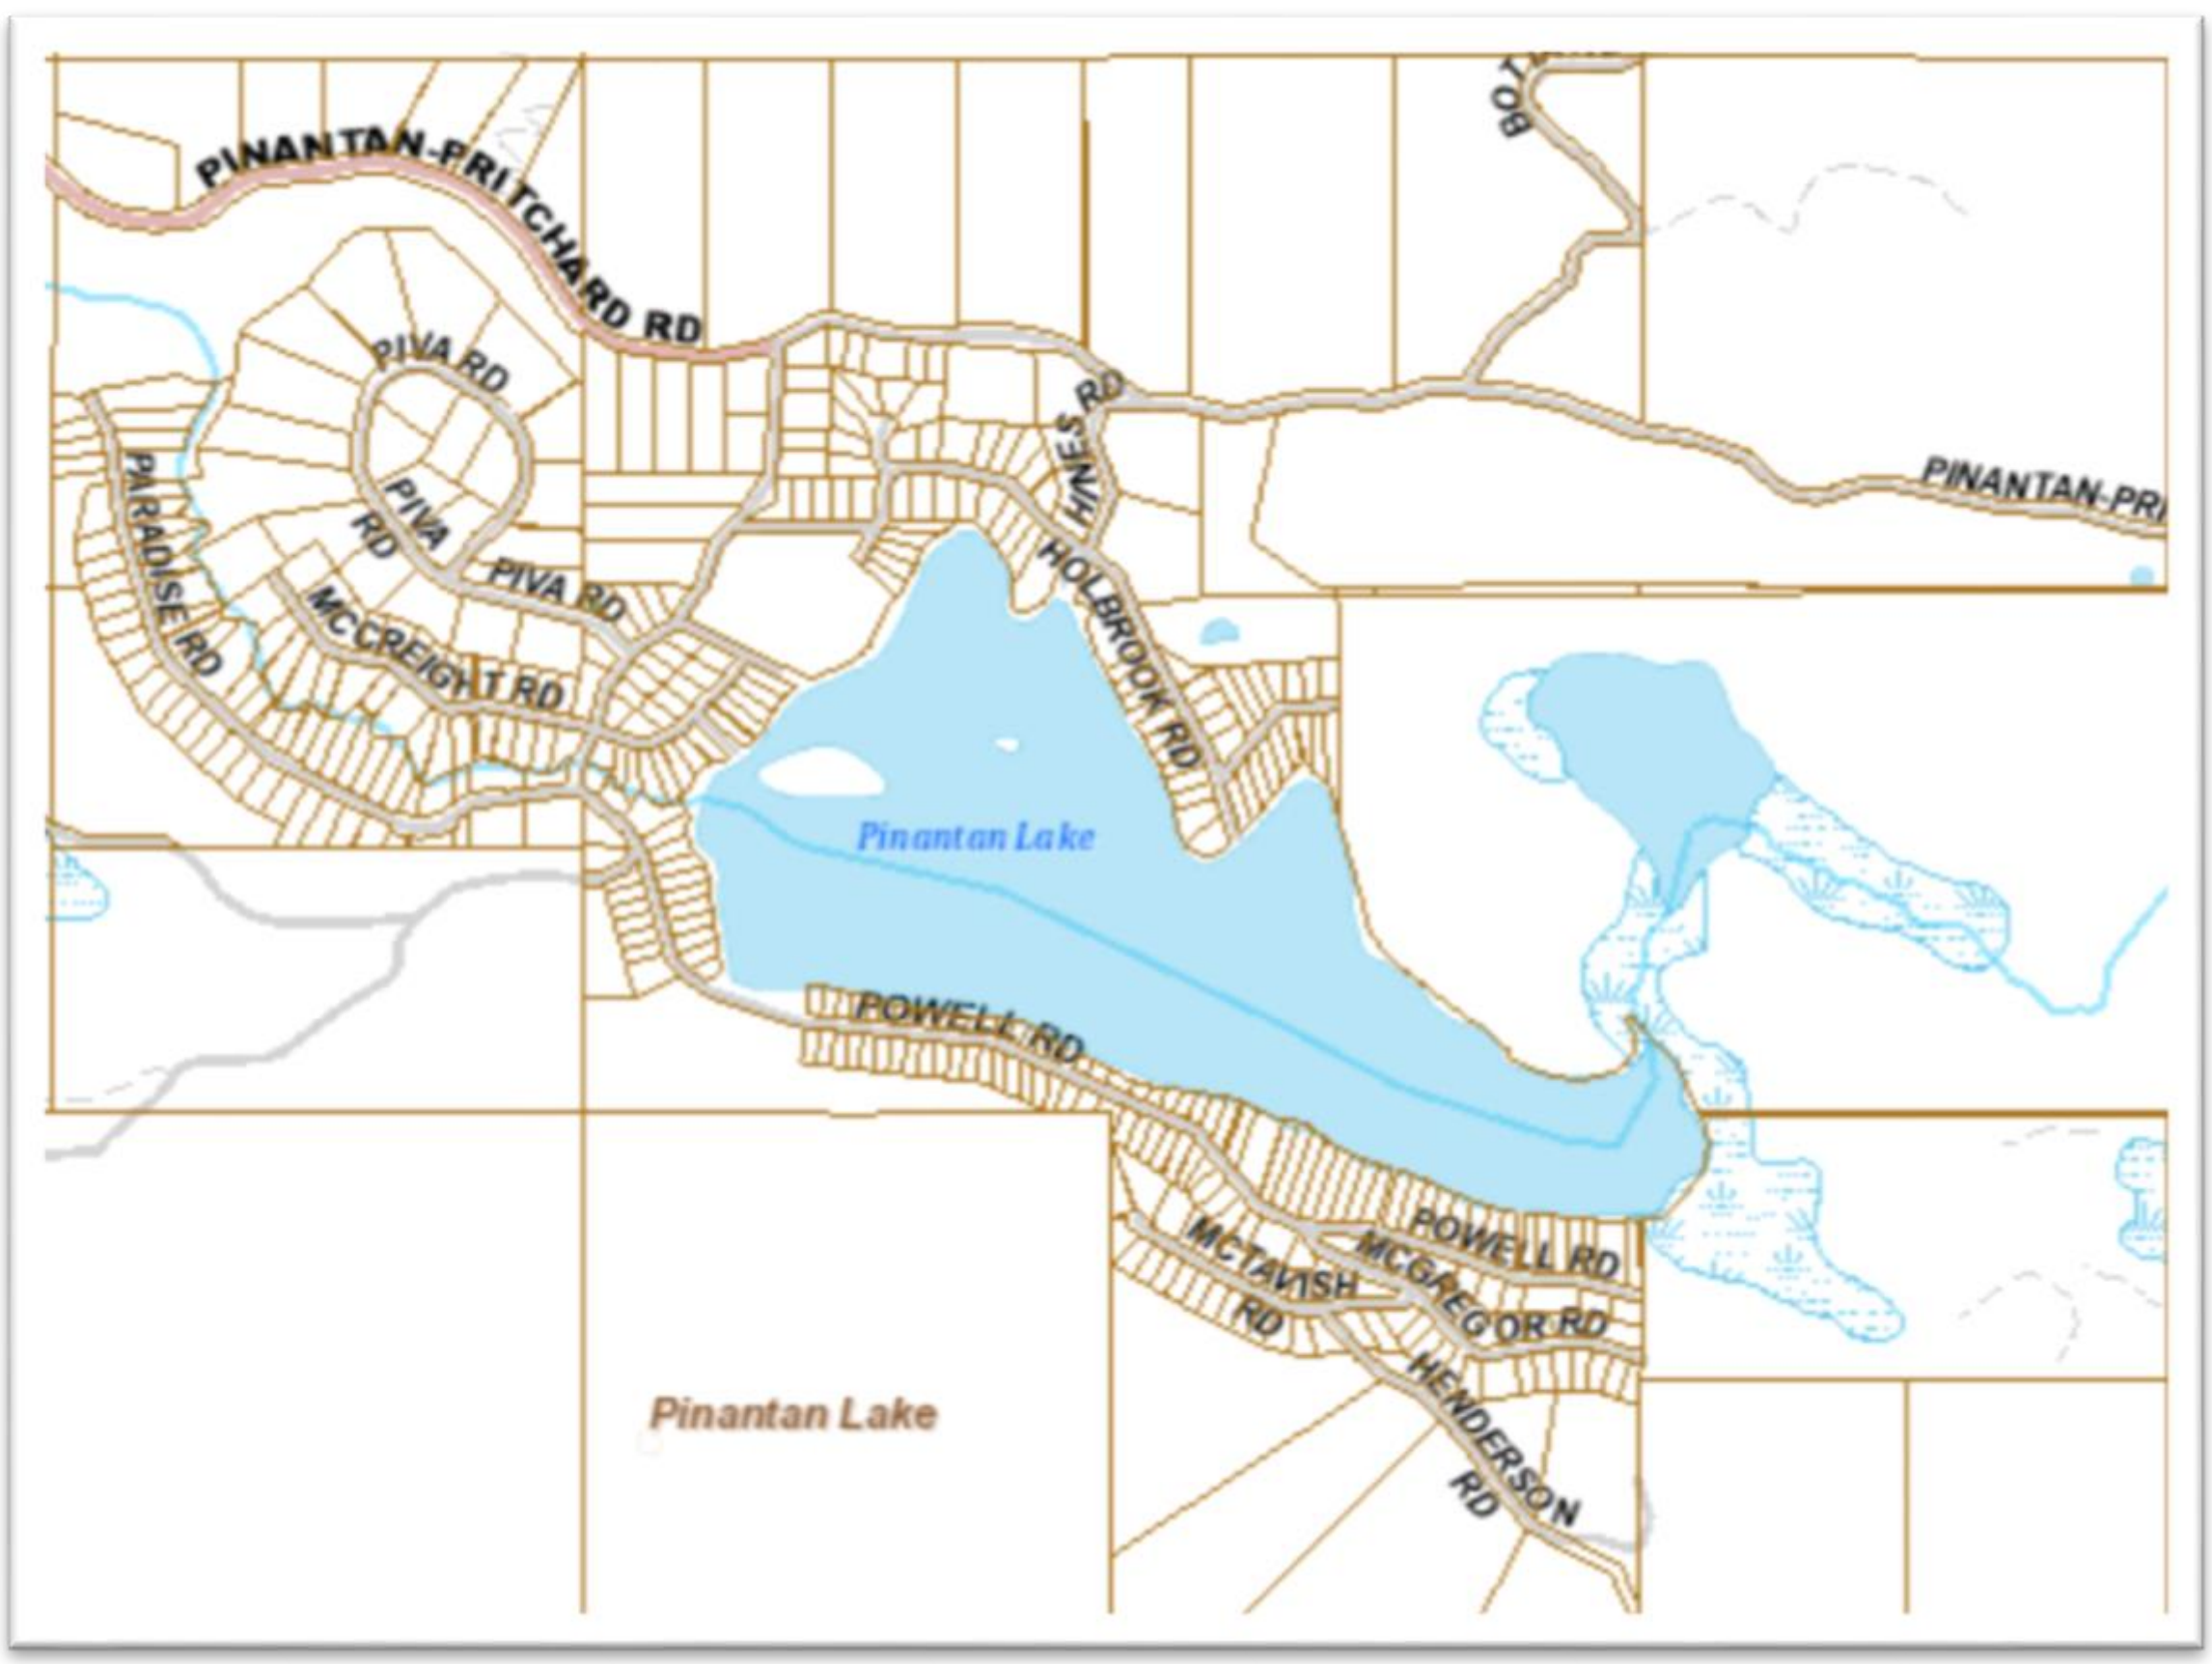
Figure 1 Pinantan Community
