Shetland Creek Fire (K70910) Detailed Post-Wildfire Natural Hazard Risk Analysis

Prepared by BGC Engineering Inc. for:

British Columbia Ministry of Forests

Post-Wildfire Natural Hazard Partial Risk Assessment (PWNHRA) for 2024 Shetland Creek Fire (K70910) – Spences Bridge, BC

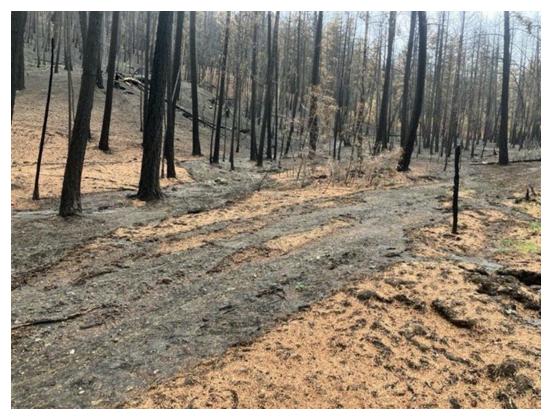
On September 25, 2024, post-wildfire debris floods occurred in numerous watersheds in the Venables Creek valley⁵ (Figure 3-3). Residents described that the rainfall was intense and short-lived (less than one hour); no rainfall gauges are available in the Venables Valley to quantify the amount of rainfall that occurred. One home in the Venables Valley (4581 Rathayatra Way) was affected by overland flooding that travelled through the property and around the house. BGC is not aware of any additional impacts to properties from this rainfall.

Figure 3-3 Overland post-wildfire flooding and sedimentation in the Venables Creek valley from the September 25, 2024 rainfall event. Photo provided by MOF (Gareth Wells).

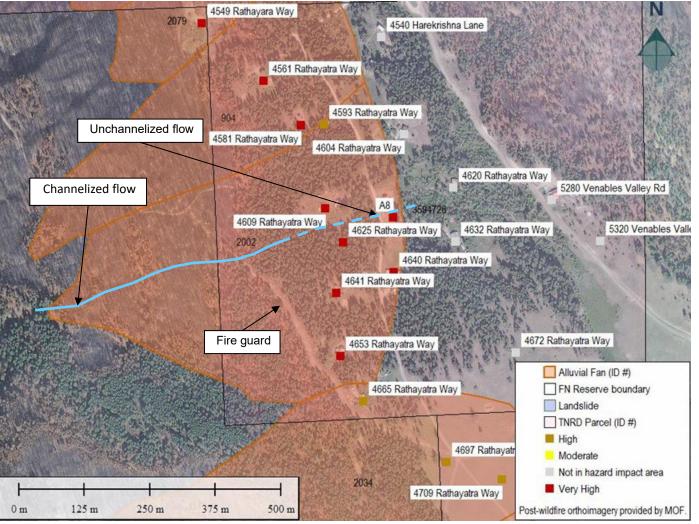
There is evidence of historical debris flows or debris floods on the proximal fan (see photo D-14). There is little evidence of recent flow in the channelized section. Several small channels are visible in MOF provided imagery in proximity to 4641 and 4653 Rathayatra Way, as such, the spatial impact likelihood is considered Moderate for 4653 Rathayatra Way as well. A fireguard runs across the alluvial fan. The channel was difficult to follow in the unchannelized area; extents of channel shown are approximate. 4665 Rathayatra Way may also be subject to hazards from watershed to the south (watershed 13). 4593 Rathayatra Way may be subject to hazards from watershed to the north (watershed 15).

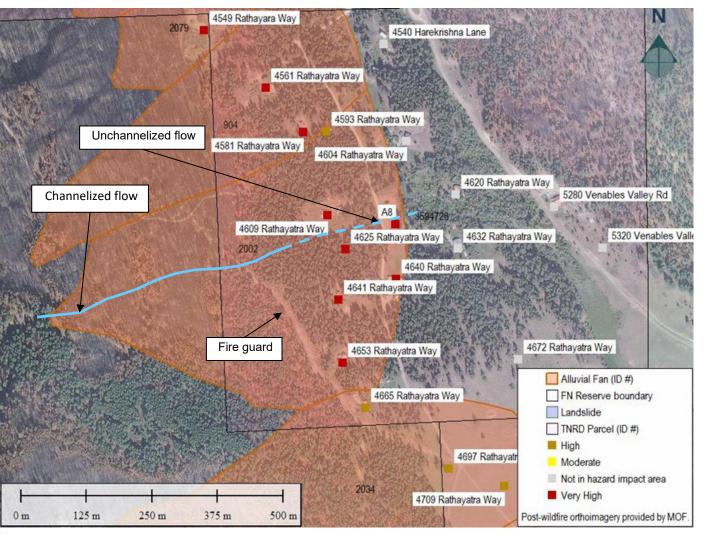
There is evidence of historical debris flows or debris floods on the proximal fan. There is little evidence of recent flow in channelized section. Several small channels are visible in MOF provided imagery in proximity to 4641 and 4653 Rathayatra Way. A fireguard runs across the alluvial fan. The channel was difficult to follow in the unchannelized area; extents of channel are approximate. 4665 Rathayatra Way may also be subject to hazards from watershed to the south (watershed 13). 4593 Rathayatra Way may be subject to hazards from watershed to the north (watershed 15).

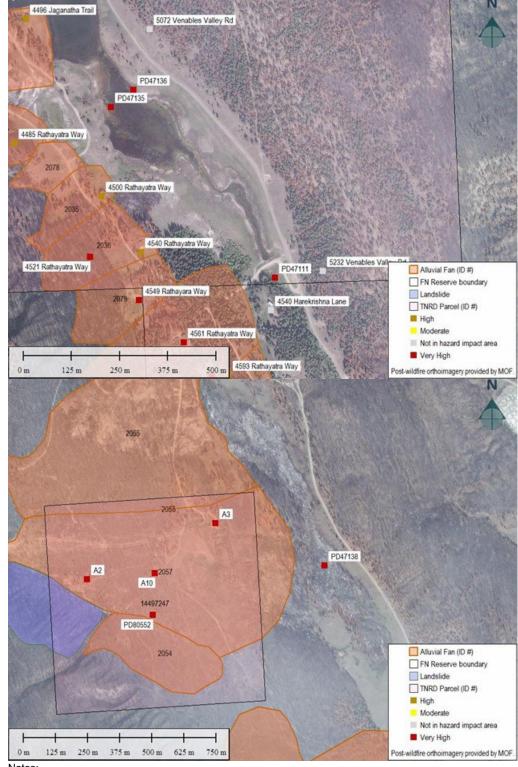
Water licenses are located in flood hazard areas of Venables Creek and are outside of debris flow hazard areas.

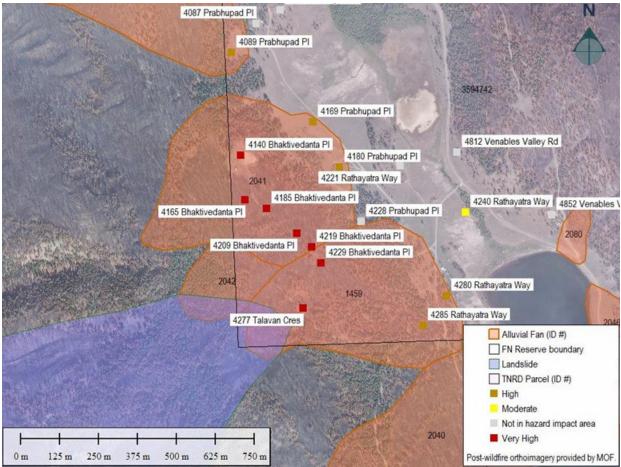
Watersheds 28 and 29 contain earthflow landslide hazards that may affect geohazard likelihood and magnitude. Evidence of historical debris flow or debris flood deposits were observed within 10 m of the home at 4277 Talavan Cres.

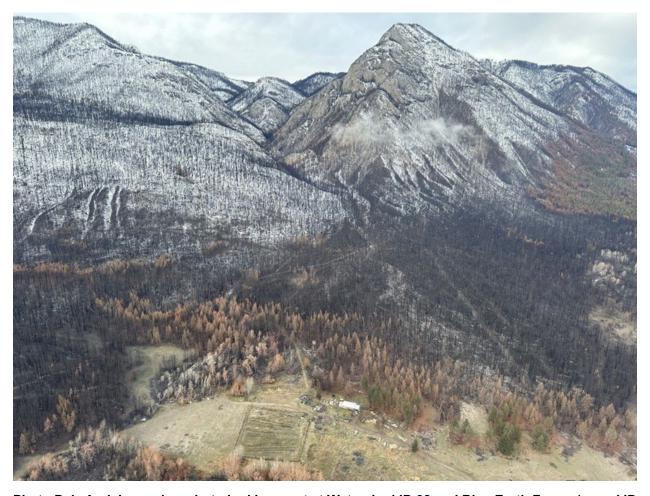
Photo D-1 Aerial overview photo looking west at Watershed ID 38 and Blue Earth Farms (parcel ID 014598388). Photo taken by BGC on November 18, 2024.

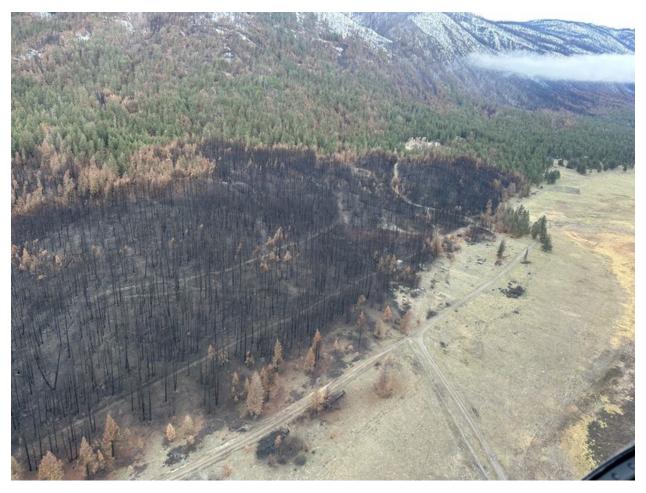
Photo D-3 Aerial overview photo looking northwest towards 4721 Minnabariet Rd block (parcel ID 003594793). Photo taken by BGC on November 18, 2024.

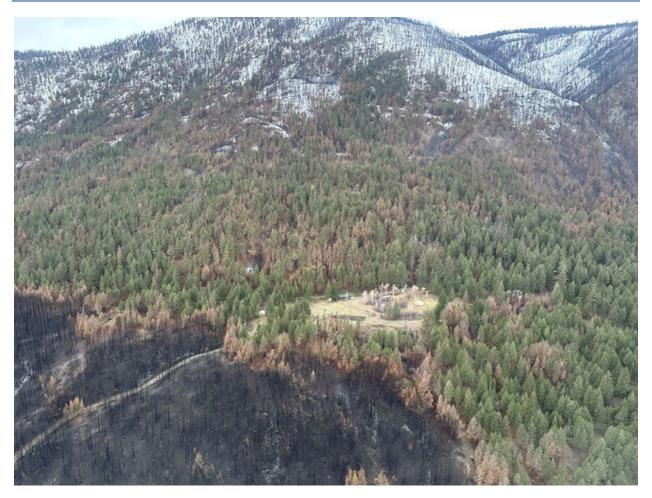
Photo D-4 Aerial overview photo looking west at 4721 Minnabariet Rd. Photo taken by BGC on November 18, 2024.

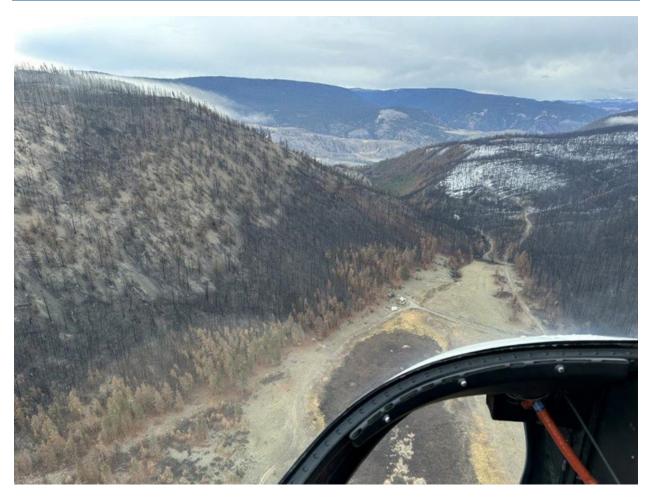
Photo D-5 Aerial overview photo looking south towards 4788 Minnabariet Rd. Photo taken by BGC on November 18, 2024.

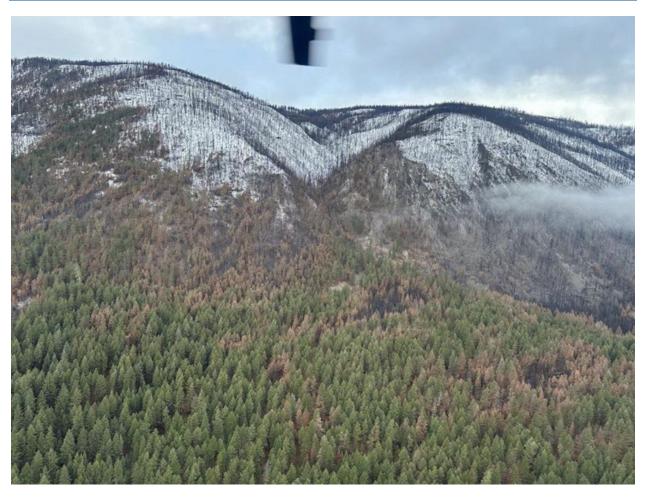
Photo D-6 Aerial photo looking west at Watershed 9 above 4665 Minnabariet Rd. Photo taken by BGC on November 18, 2024.

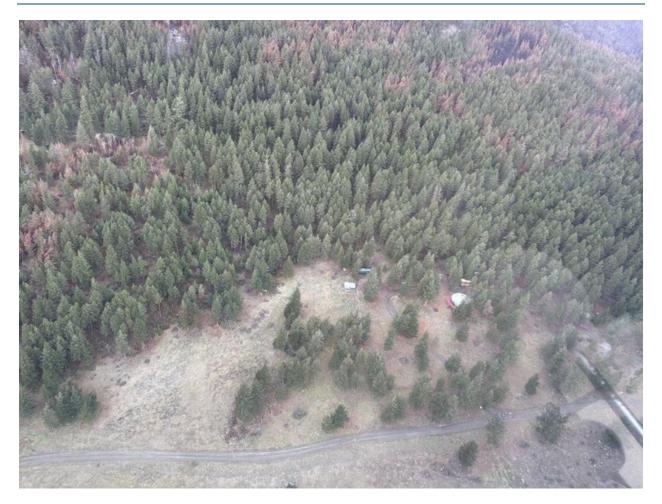
Photo D-8 Aerial overview photo of 4665 Minnabariet Rd taken by BGC on November 18, 2024.

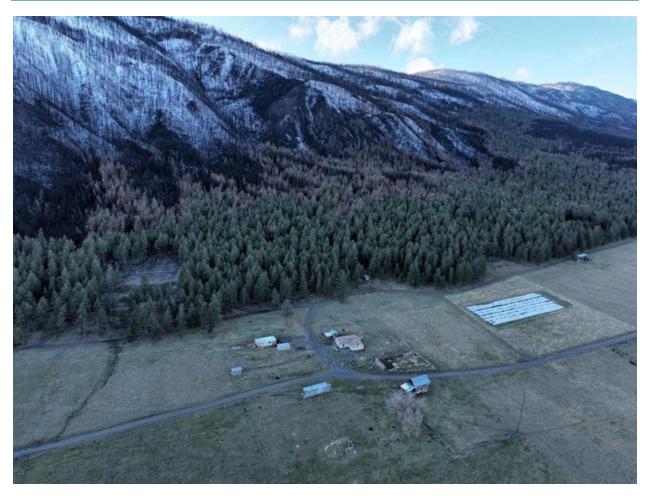
Photo D-9 Aerial overview photo looking northwest at 4757 Govardan Hill Terr, 4789 Govardan Hill Terr, and 4501 Minnabariet Rd. Photo taken by BGC on November 17, 2024.

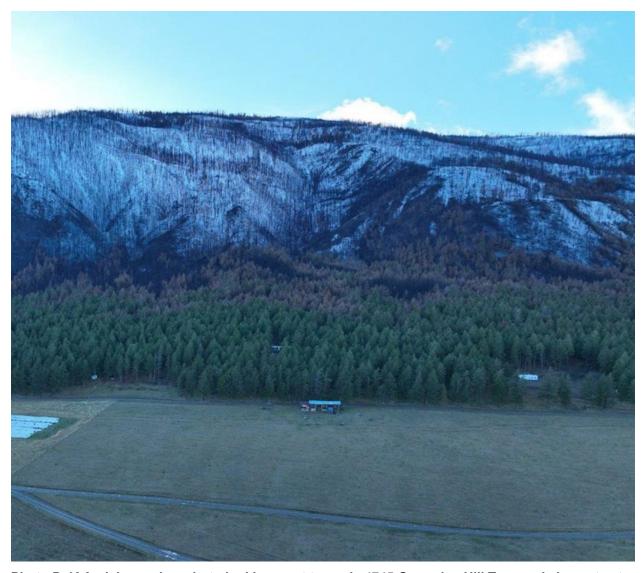
Photo D-10 Aerial overview photo looking west towards 4745 Govardan Hill Terr, and elements at risk A5 (no address), and A9 (no address). Photo taken by BGC on November 17, 2024.

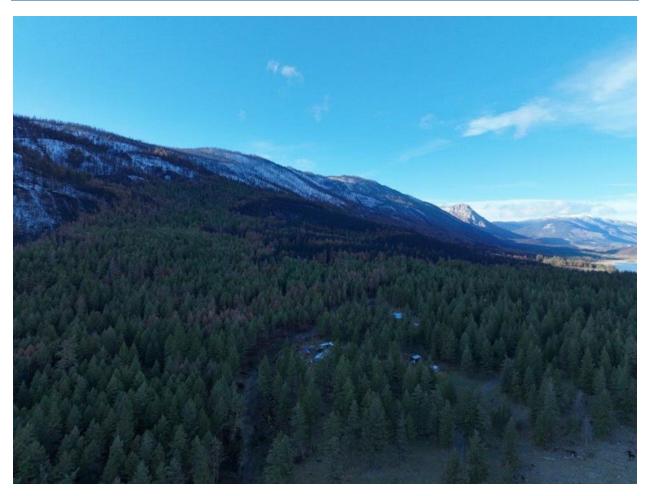
Photo D-11 Aerial overview photo looking north towards 4653 Rathayatra Way and 4665 Rathayatra Way. Photo taken by BGC on November 17, 2024.

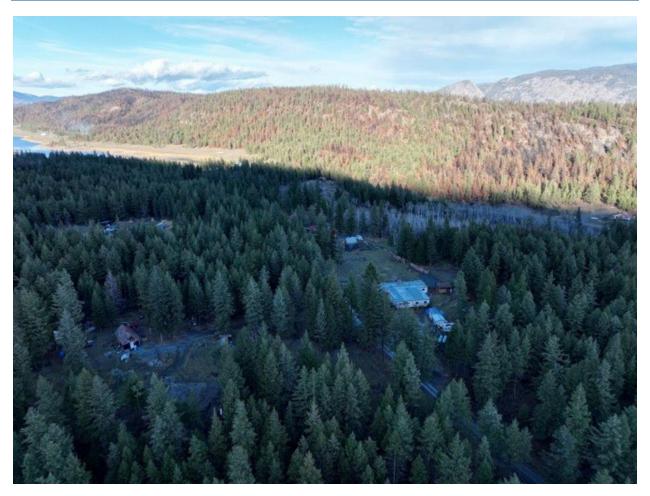
Photo D-12 Aerial overview photo looking northeast towards elements around the 4600 Rathayatra Way block. Photo taken by BGC on November 17. 2024.

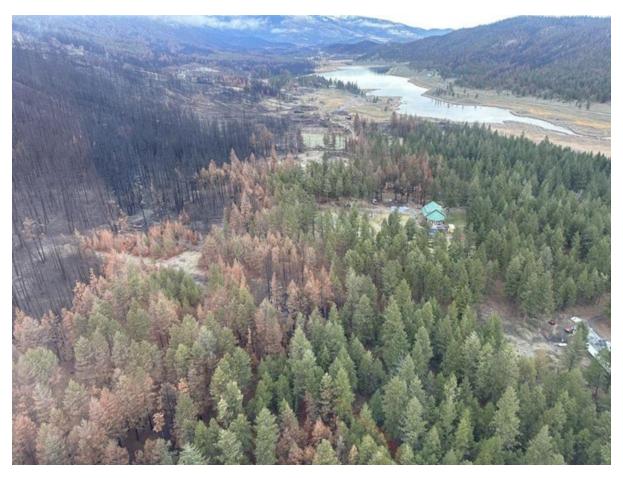
Photo D-13 Aerial overview photo looking north at 4581 Rathayatra Way and 4561 Rathayatra Way. Photo taken by BGC on November 18, 2024.

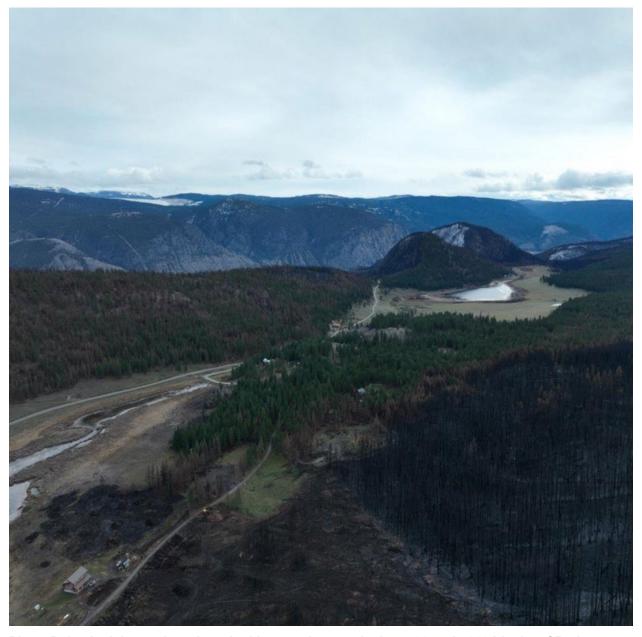
Photo D-15 Aerial overview photo looking south towards the 4500 and 4600 blocks of Rathayatra Way. Photo taken by BGC on November 17, 2024.

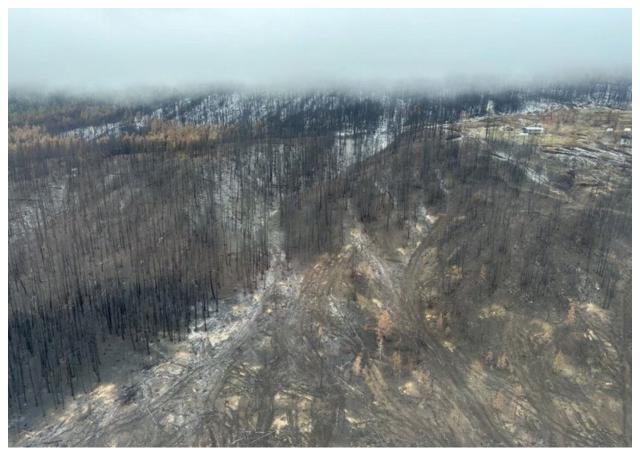
Photo D-16 Aerial photo looking west towards the watershed above Fan 2036 and Fan 2037. Note 4544 Talavan Cres is visible on the right. Photo taken by BGC on November 18, 2024.

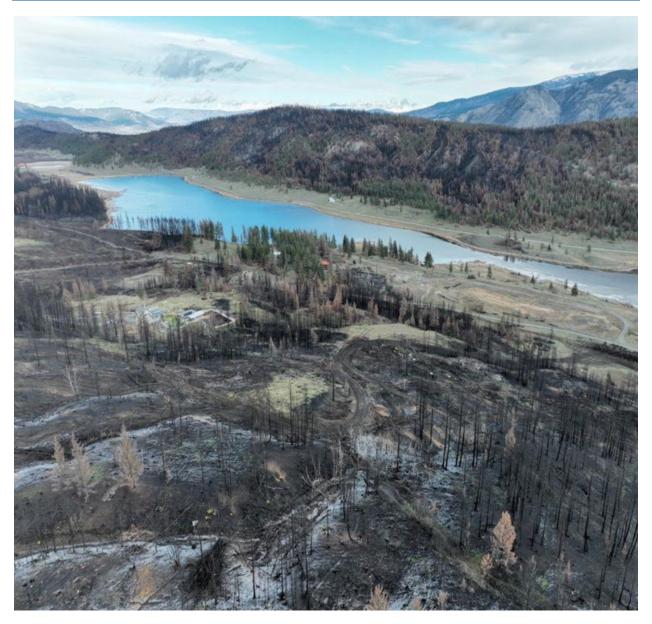
Photo D-17 Aerial overview photo looking northeast towards the 4400 Rathayatra Way block. Photo taken by BGC on November 17,2024.

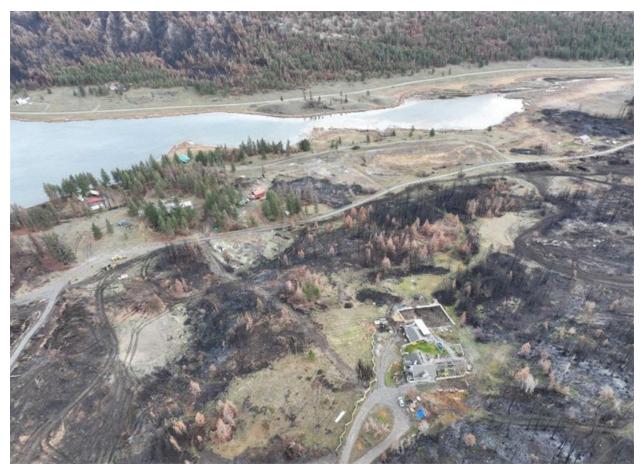
Photo D-18 Aerial overview photo looking east at the 4400 Rathayatra Way and 3300 Jaganatha Trail blocks. Photo taken by BGC on November 17, 2024.

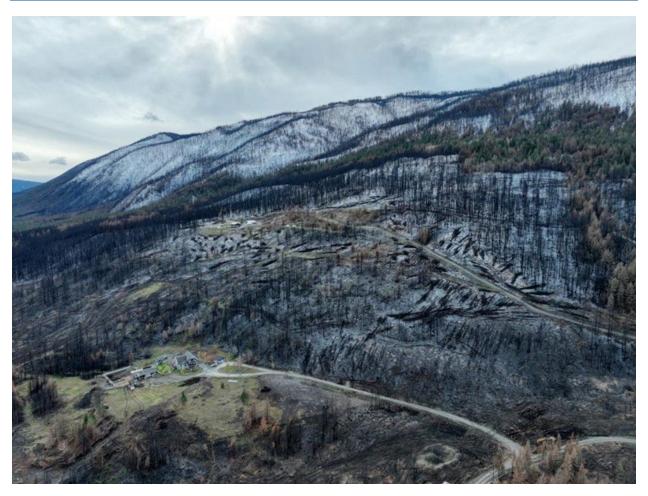
Photo D-19 Aerial overview photo looking southeast towards 4544 Talavan Cres and 4469 Rathayatra Way. Photo taken by BGC on November 17, 2024.

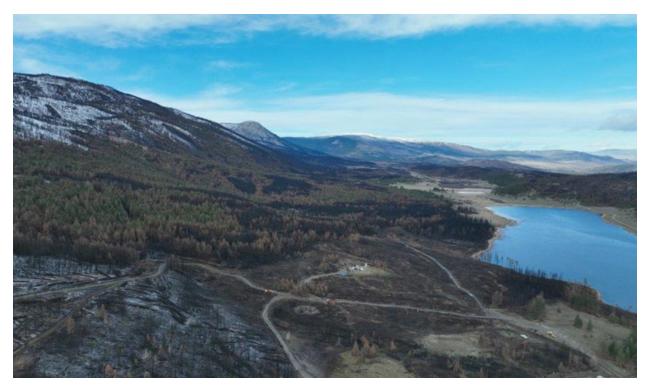
Photo D-20 Aerial overview photo looking north towards 4433 Bahki Blvd. Photo taken by BGC on November 17, 2024.

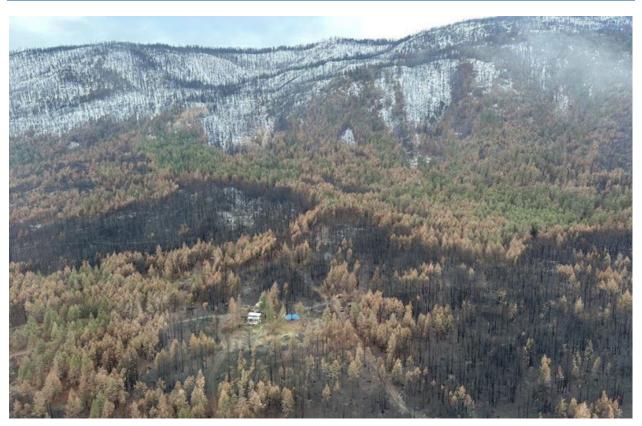
Photo D-21 Aerial overview photo looking west at 4277 Talavan Cres. Photo taken by BGC on November 18, 2024.

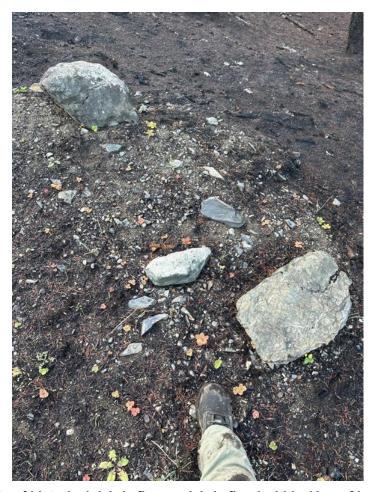
Photo D-22 Deposits of historical debris flow or debris flood within 10 m of home at 4277 Talavan Cres. Photo taken by BGC on November 17, 2024.

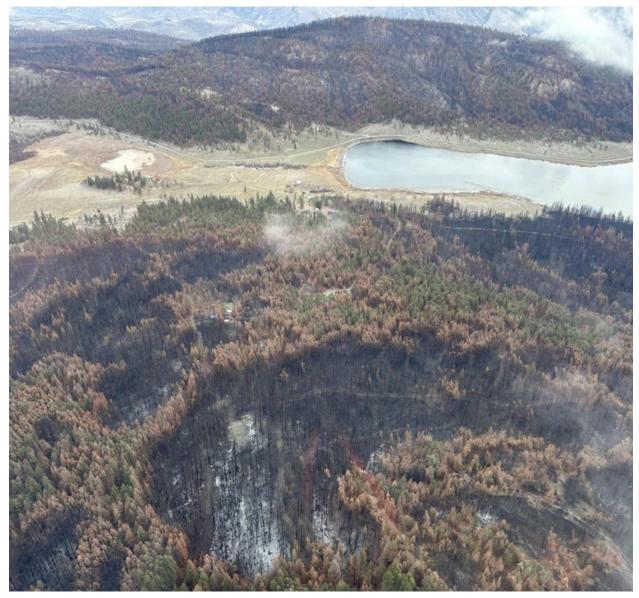
Photo D-23 Aerial overview photo looking east towards 4277 Talavan Cres and 4286 Rathayatra Way. Photo taken by BGC on November 18, 2024.

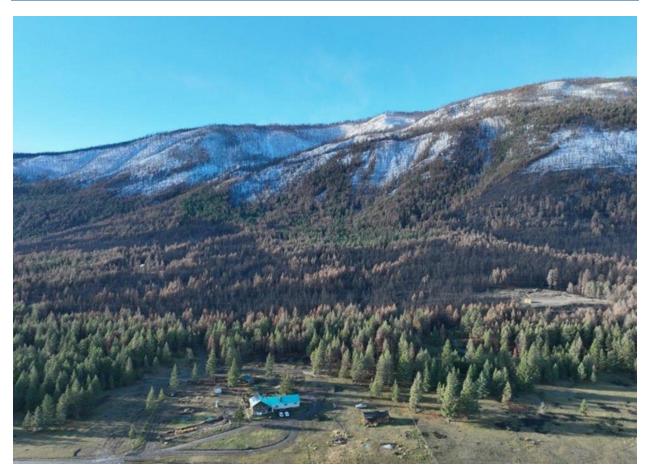
Photo D-24 Aerial overview photo looking west at 4180 Prabhupad PI (center-bottom) and towards 4277 Talavan Cres (center-left). Photo taken by BGC on November 17, 2024.

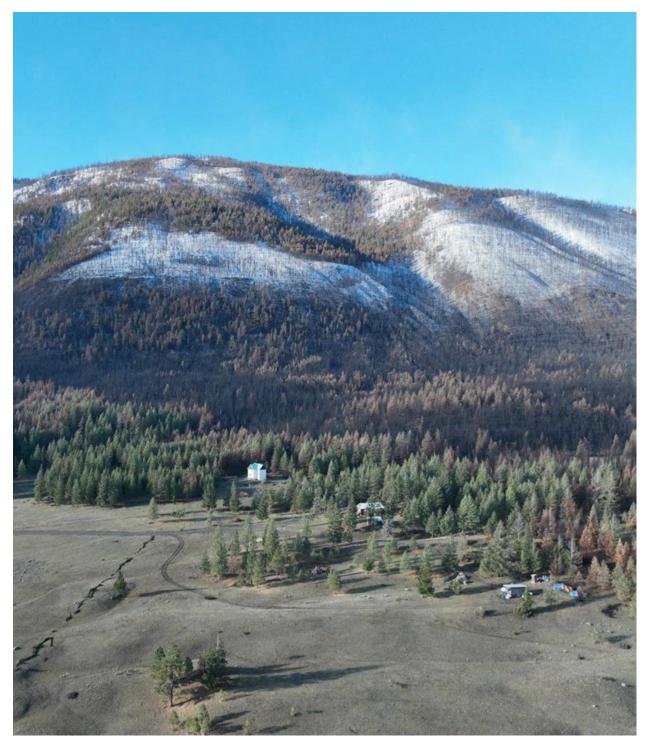
Photo D-25 Aerial overview photo looking west at 4000 Prabhupad Pl block (4089 Prabhupad Pl center-left). Photo taken by BGC on November 17, 2024.

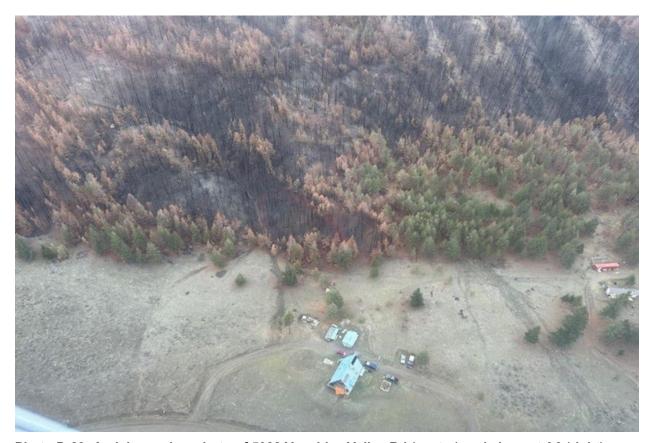
Photo D-29 Aerial overview photo of 5028 Venables Valley Rd (center) and element A6 (right).

Note the evidence of overland flow left of 5028 Venables Valley Rd and between 5028 Venables Valley Rd and element A6. Photo taken by BGC on November 18, 2024.

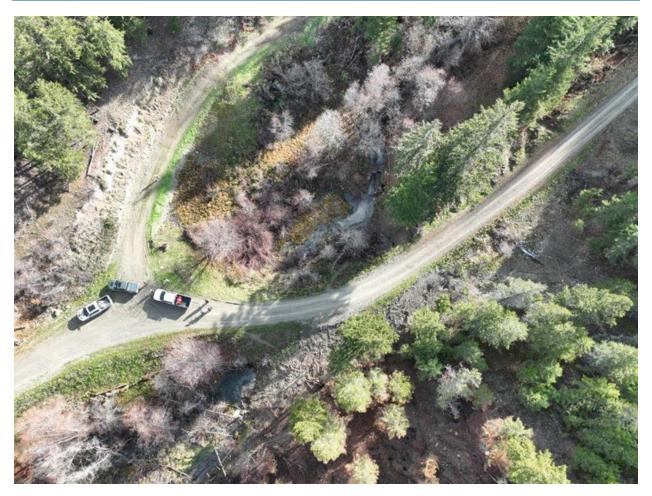
Photo D-32 Aerial overview photo of PD45750 water intake structure along Twaal Creek (centertop). Photo taken by BGC on November 18, 2024.

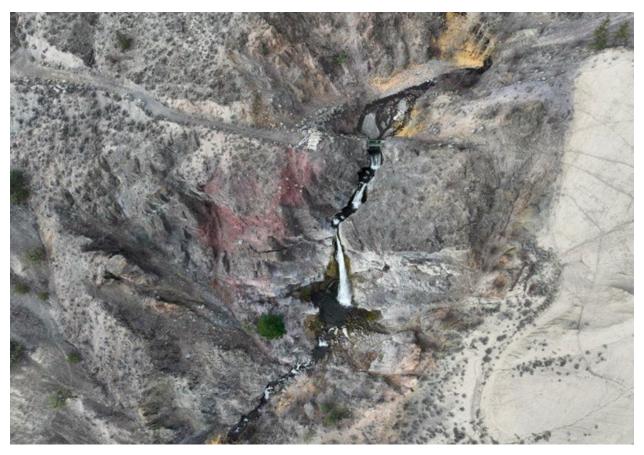
Photo D-36 Aerial overview photo of Murray Creek Falls where PD45760, PD45761, and PD45762 are located. Photo taken by BGC on November 19, 2024.
